PROPOSED BRILAND RESIDENCES & MARINA

UTILITY SECTIONS
SCALE: N.T.S.

EIA Addendum · 4M Harbour Island Project · 3 December 2020

ISLAND DIMENSIONS DEVELOPMENT CO. LTD.
4M HARBOR ISLAND DEVELOPMENT
SEWER FLOW CALCULATIONS

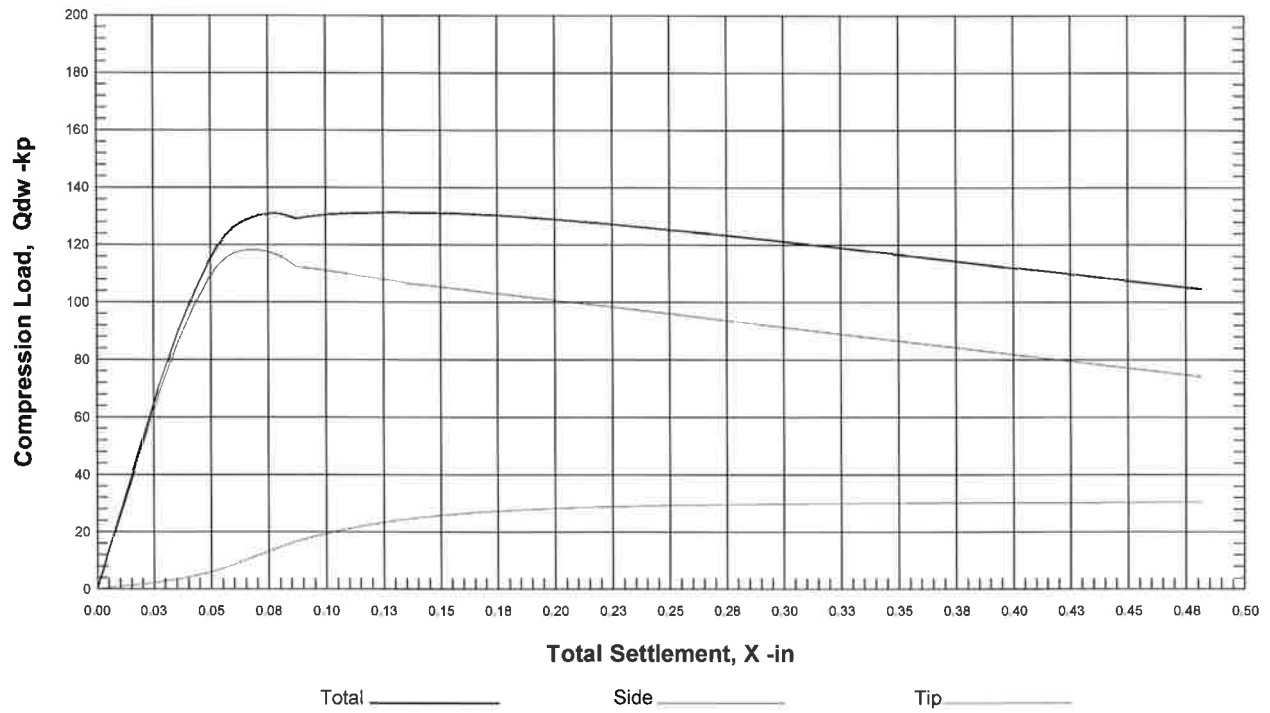
HARBOUR ISLAND DEVELOPMENT
14X14 CONC. PILES - 30FT LONG

SOIL STRESS, SIDE RESISTANCE, & AXIAL FORCE vs DEPTH Based on Ultimate Load Condition

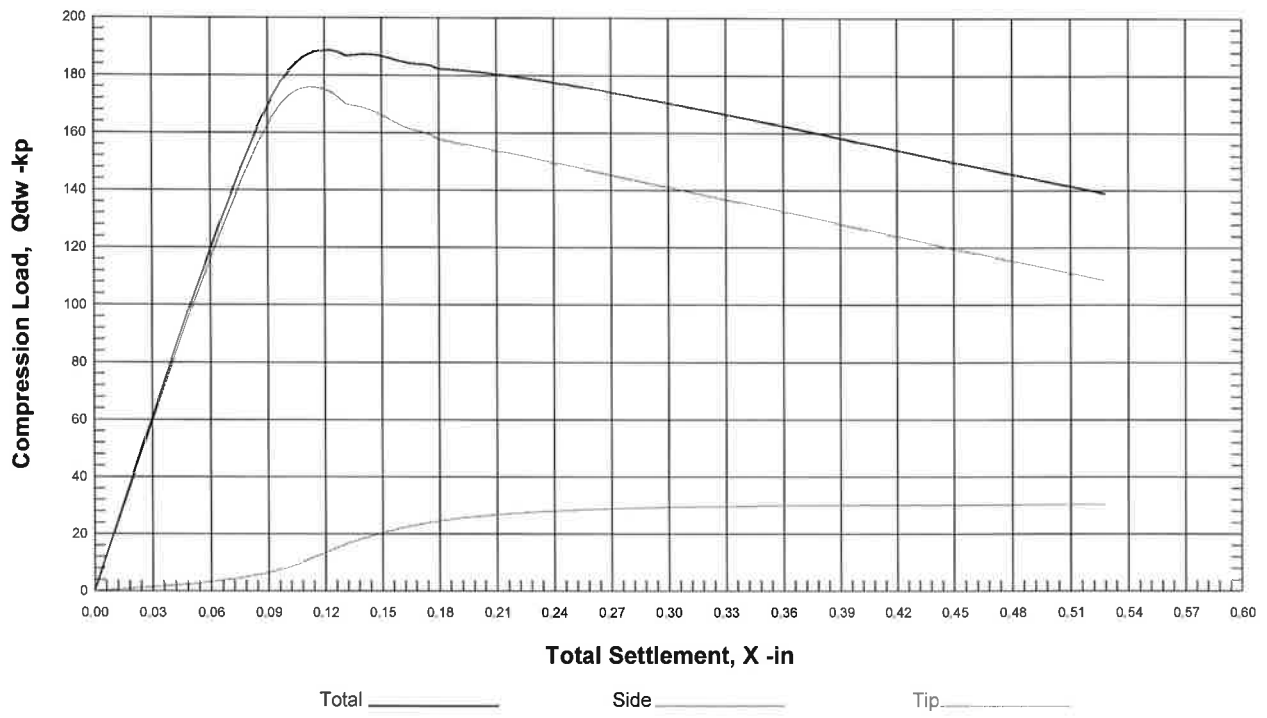
HARBOUR ISLAND DEVELOPMENT
14X14 CONC. PILES - 42FT LONG
