# 4M Harbour Island Ltd. Marina Back of House & Utility Corridor Impact Assessment Rev 1

# Utility Corridor & Back of House Description

#### **Utility Corridor**

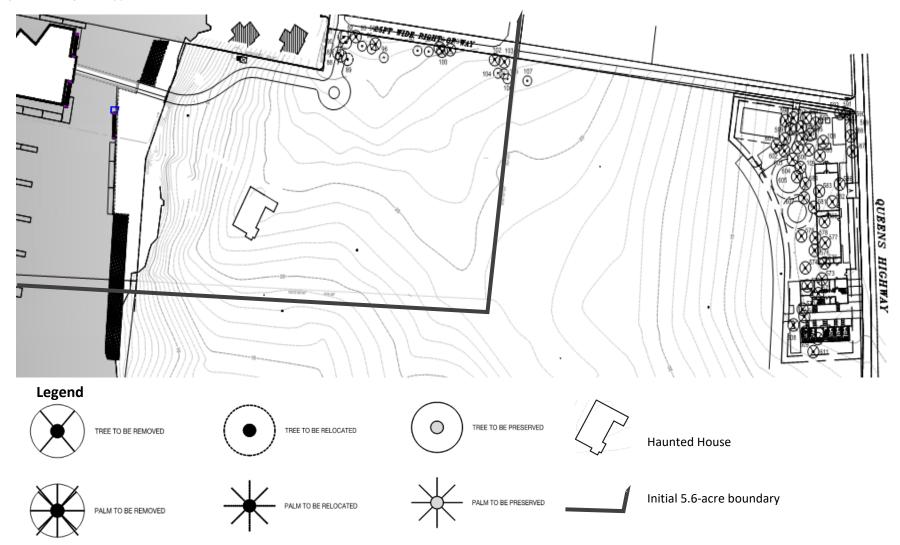
Figure 2 Utility Corridor shown with red arrow connecting 5.61 acres to Back of House area. Trees to be removed are classified using the symbols shown in the Legend and are further identified in Appendix A.

The Utility Corridor will connect the Marina to the Back of House area as shown in Figure 2. It will be constructed within the northern property boundary. 50% of the paved 25 feet wide right of way road will be incorporated in the Utility Corridor and the remaining 50% will remain open during construction. Once construction of the Corridor is complete, the 25ft right of way road will be reestablished. The Utility Corridor will also include the former entrance of the Harbour Island Marina and the previously cleared land as shown in the habitat map. Potable water lines, sanitary, electrical and fuel lines will be installed in the Utility Corridor. The figure below shows the location of the fuel tanks within the Utility Corridor. Appendix B shows the Fuel Tank drawings.

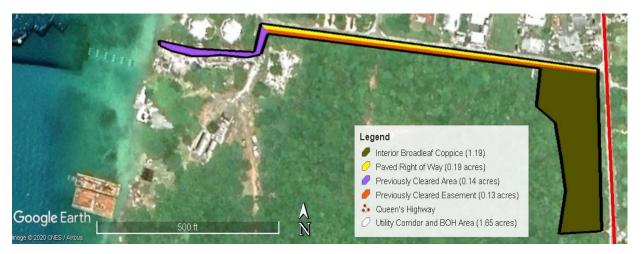
Figure 5. Habitat Map showing Utility Corridor and BOH outlined in black (Google Earth, 2020).

The Utility Corridor and BOH area will impact 1.65 acres of land as shown in the habitat map. Trees that will be impacted were tagged and numbered by the Landscape Architect, Mr. Tyler Nielson, and are shown in Appendix A. Much of the Utility Corridor will be constructed on 0.46 acres of previously cleared land. The figure below shows this area. The total amount of Interior Broadleaf Coppice impacted by the Utility Corridor and BOH will be 1.19 acres. Appendix A includes the list of plants identified by Mr. Nielson and Mr. Franklin Hall. Curriculum Vitaes for both consultants are included in Appendix D. The habitat map and supporting photos for the Area of Impact are shown on the following pages.

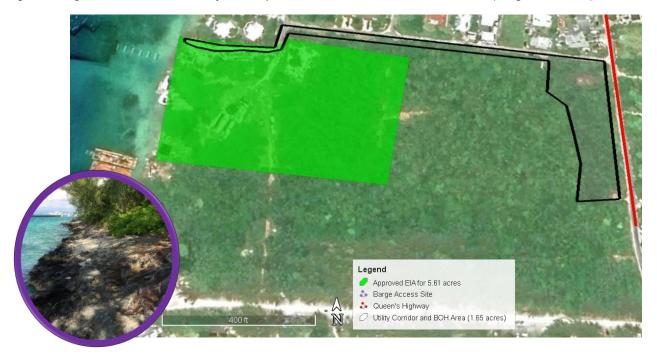
Figure 13 Barge access area is southwest of the Utility Corridor and BOH area in Dunmore Harbour (Google Earth, 2020)

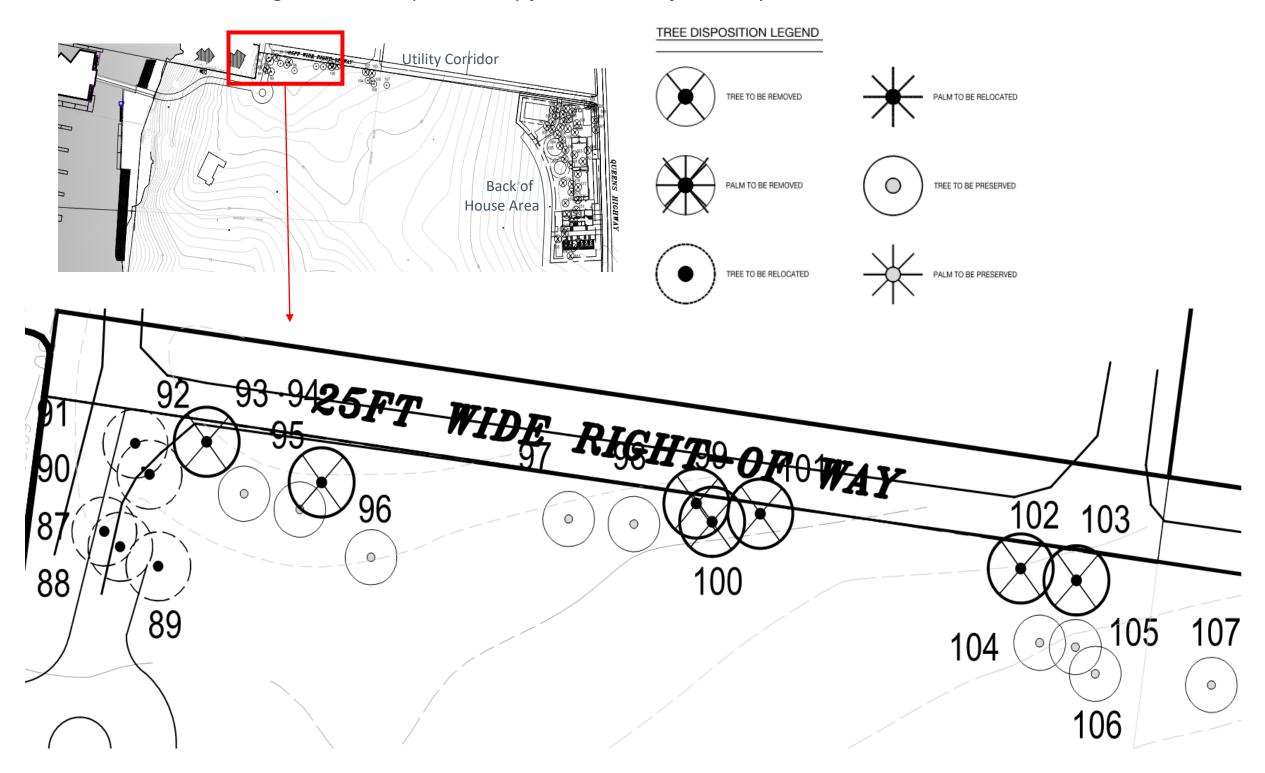
Figure 14 Tree Disposition Map for the section of the Utility Corridor shown in red.

#### FIGURES 14 – 16 SHOW LOCATIONS FOR THE SPECIES LISTED IN THE FOLLOWING TABLES.

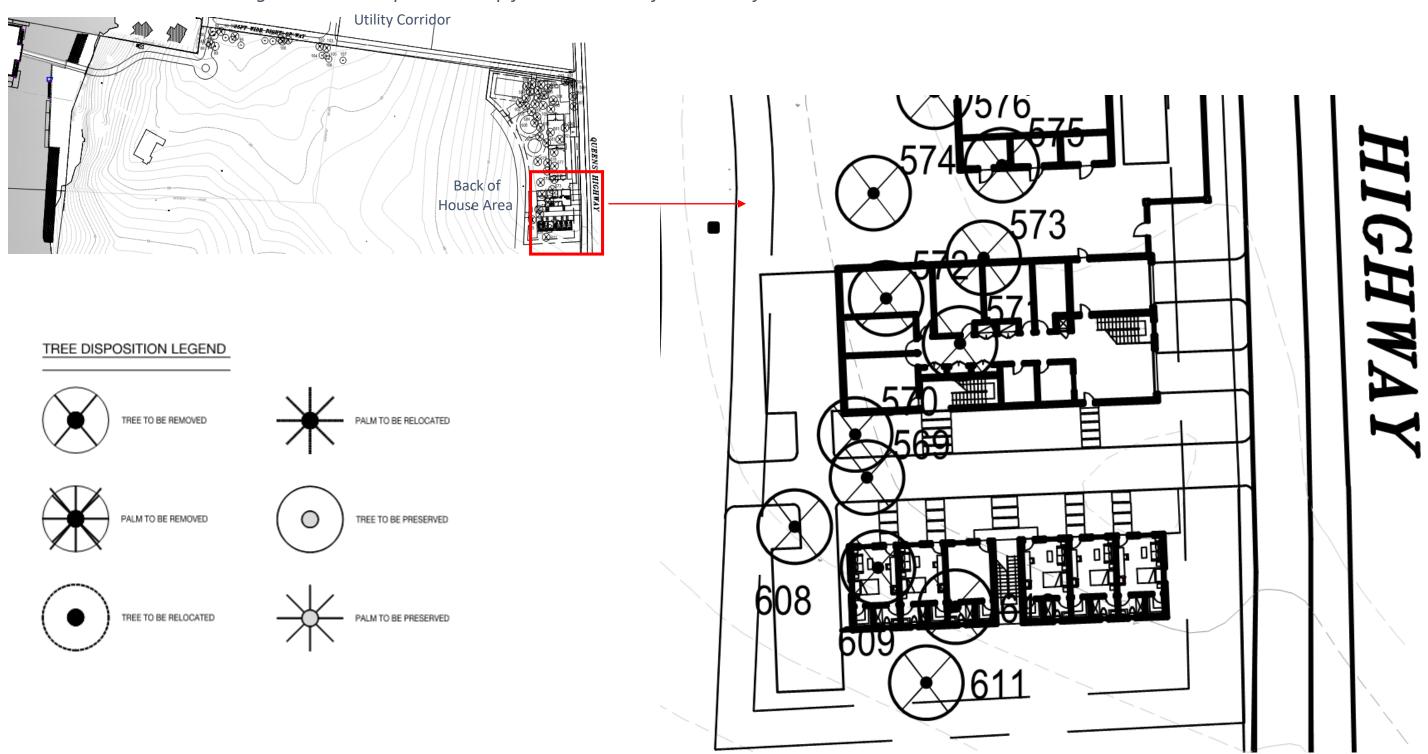
Figure 16 Tree Disposition Map for the section of the Back of House area shown in red.

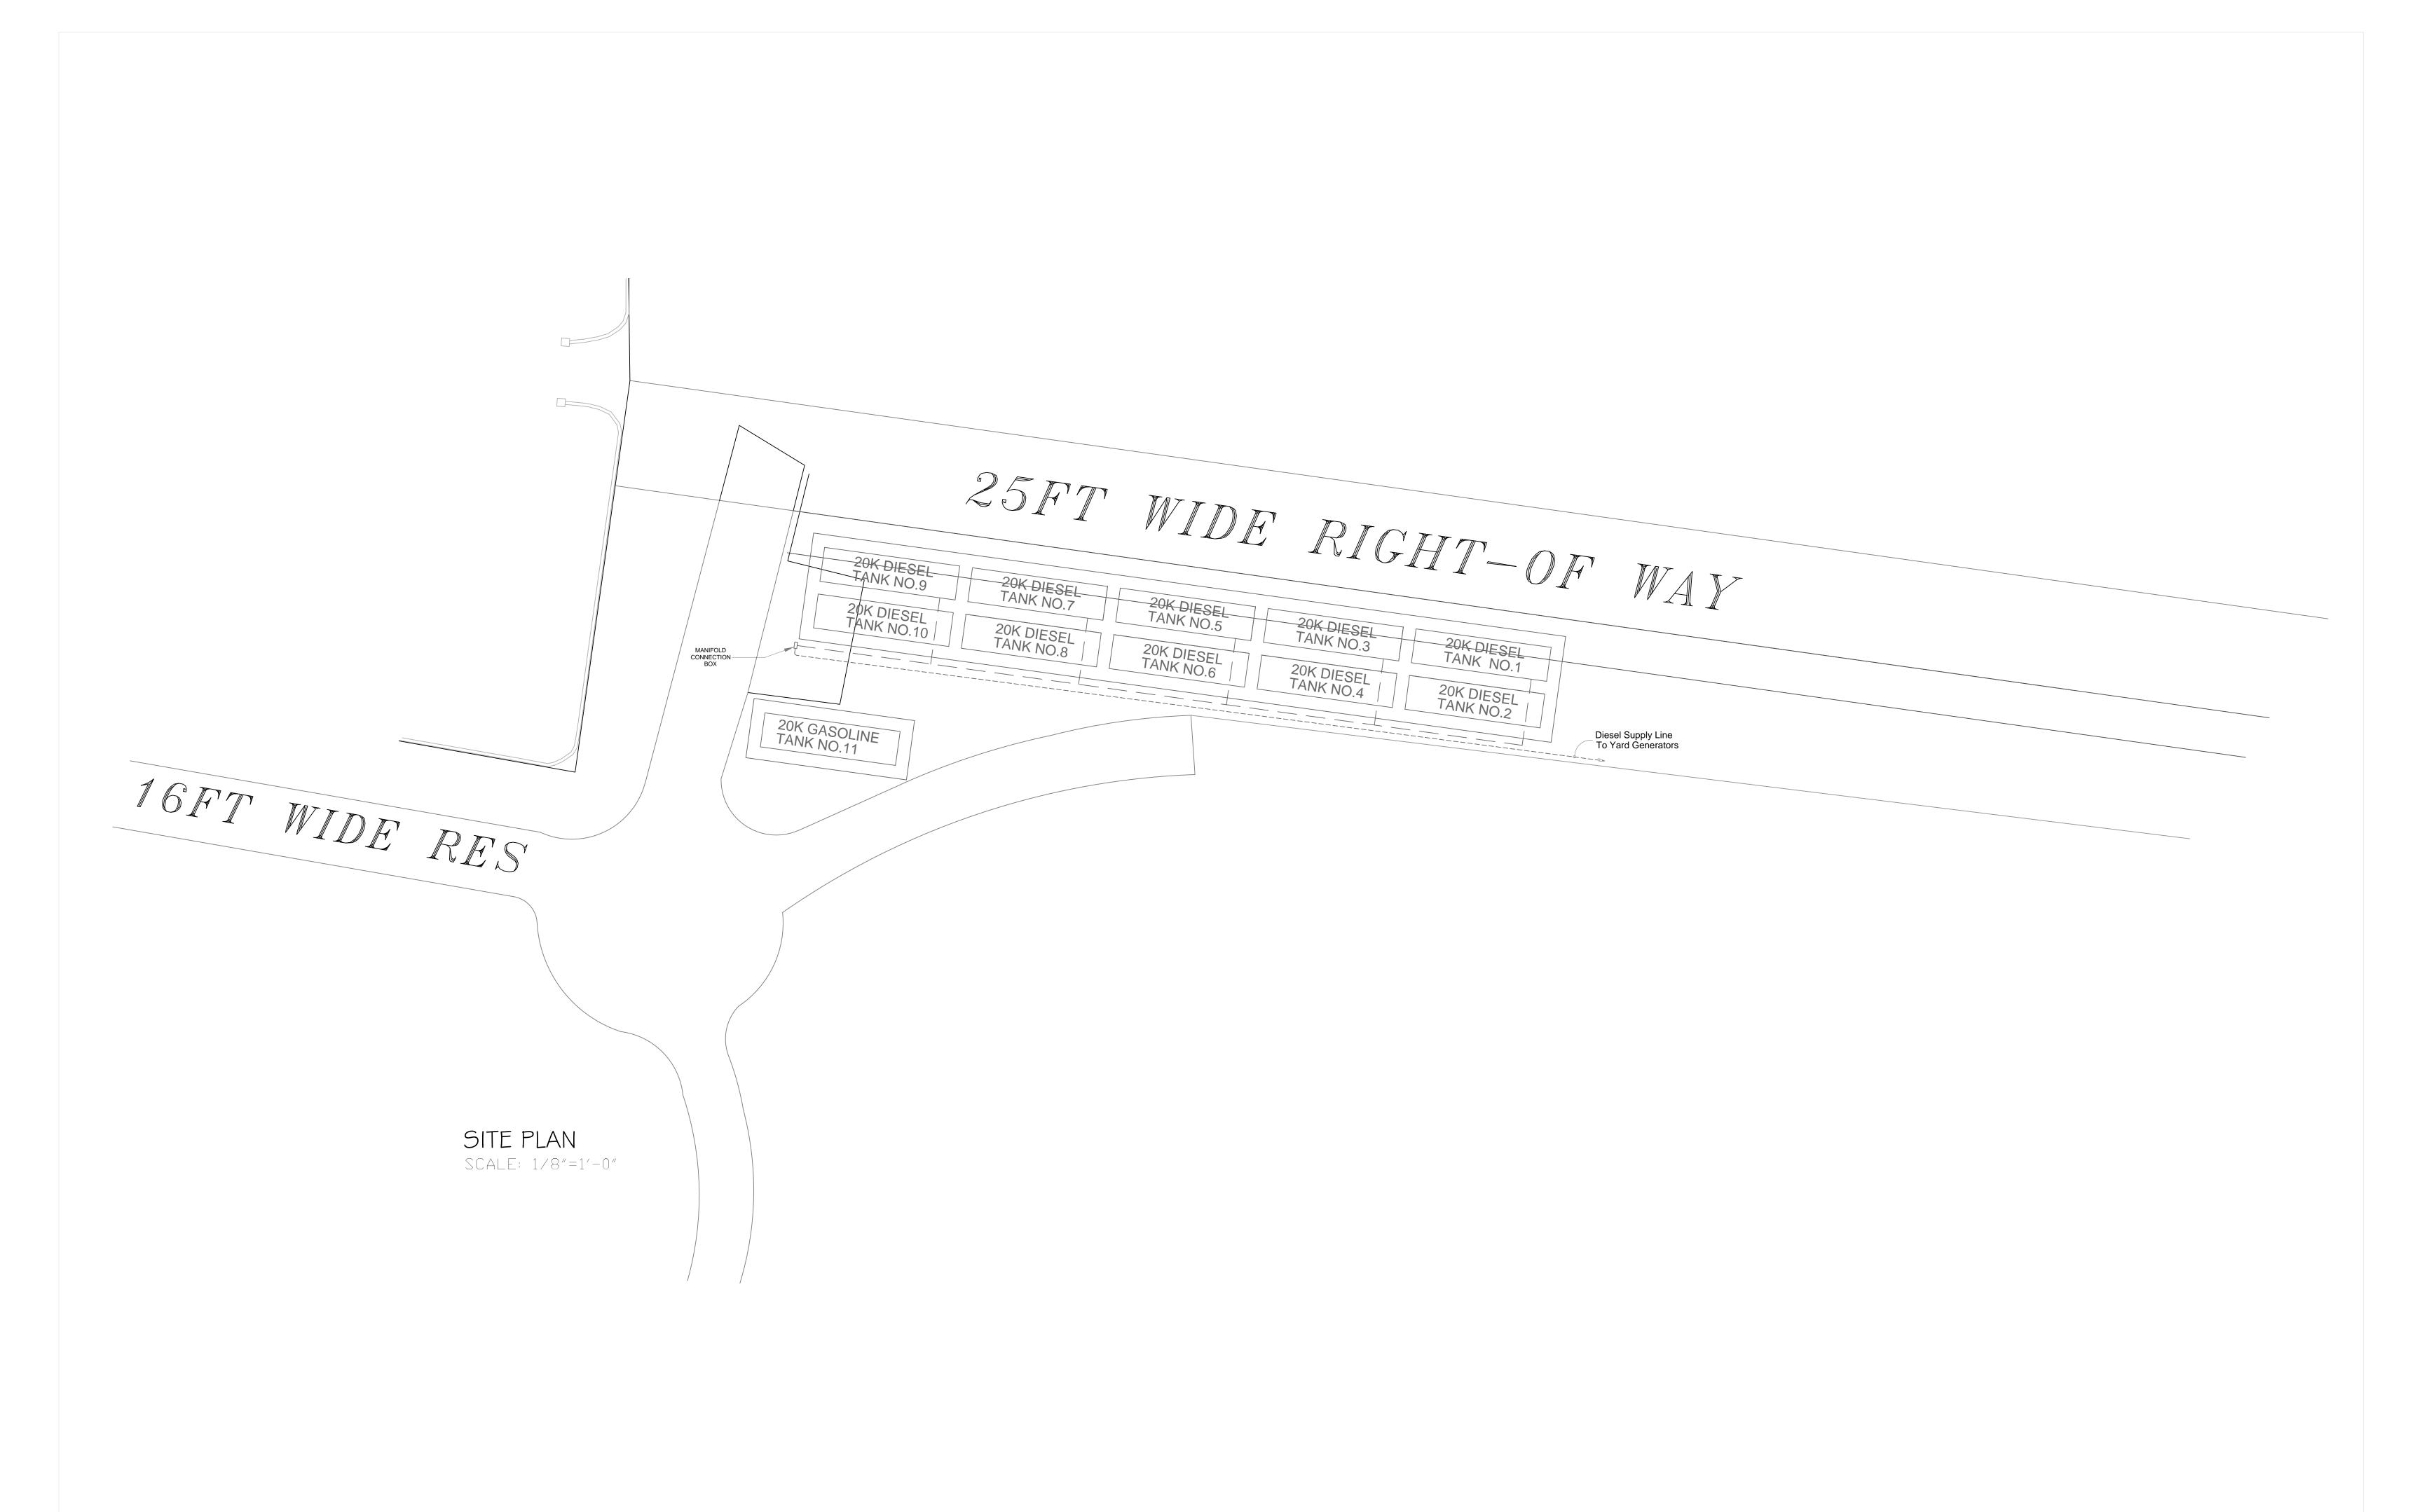
4M HARBOUR ISLAND 2 L	DTD TO SUPPORT MARINA   DRAWING TITLE : SITE PLAN -	FUEL TANKS  SCALE: AS SHOWN DATE: NOVEMBER	CHECKED: CTI  3 2020 DRAWN: CST	Island Dimensions &	Consulting Civil, Structural & Environmental Engineers Project Managers, Cost Engineers Land Planners & Developers, License Contractors	Farrington House, Gladstone Road P. O. Box EE-15036 Nassau, Bahamas	SHEET No. A-02
NΘ	REVISIONS	DATE BY №	REVISIONS	DATE BY PACKAGE: FOR PERMITTING	HARBOUR ISLAND, THE BAHAMAS	JOB NO.: 0000-20	APPROVED: CTI	Development Company LT		Tel#: (242)-341-6318/25 Fax#: (242)-361-6312

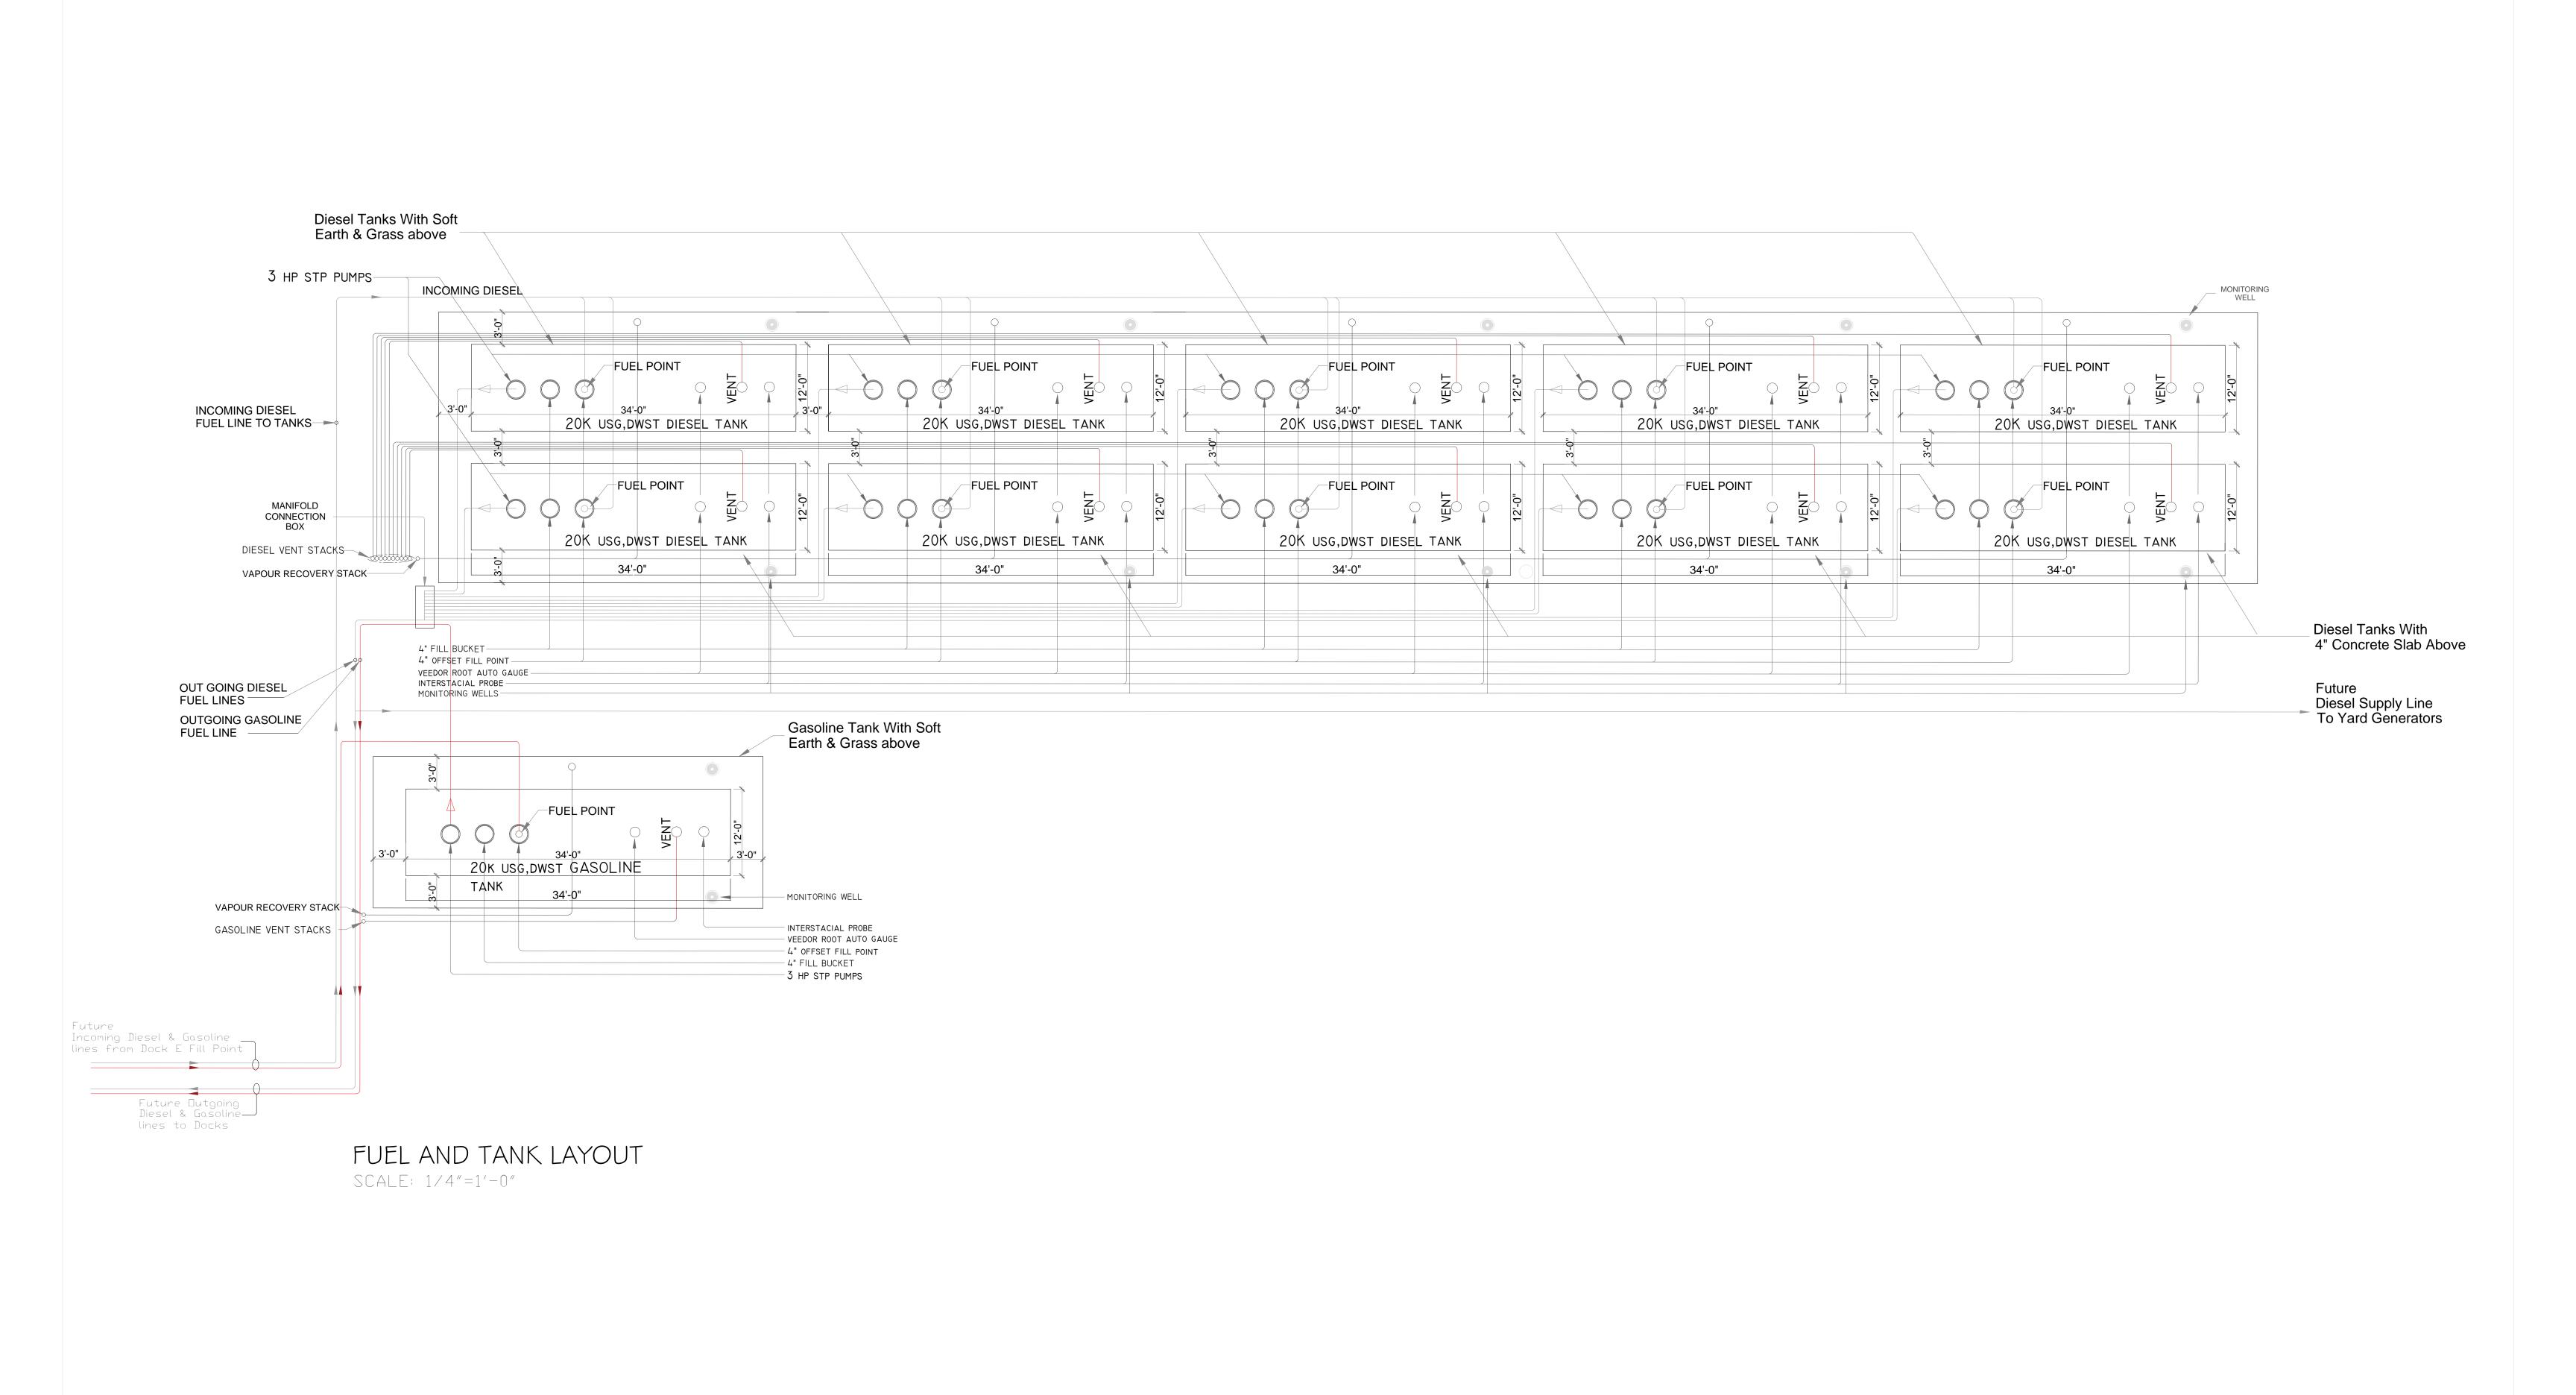
4M HARBOUR ISLAND LTD. 4M HARBOUR ISLAND 2 LTD TO SUPPORT MARINA	RAWING TITLE : SCALE: AS SHOWN CHECKED: CTI  UEL TANK LAYOUT  DATE: NOVEMBER 3, 2020 DRAWN: CST	Island Dimensions & Consulting Civil, Structural & Environmental Engineers Project Managers, Cost Engineers Development Land Planners & Developers, License Contractors	Farrington House, Gladstone Road  P. O. Box EE-15036  Nassau, Bahamas  Tel#: (242)-341-6318/25
Nº REVISIONS DATE BY №	REVISIONS DATE BY PACKAGE: FOR PERMITTING HARBOUR ISLAND, THE BAHAMAS	JOB NO.: 0000-20 APPROVED: CTI	Company LTD.	Fax#: (242)-341-6318/25 Fax#: (242)-361-6312

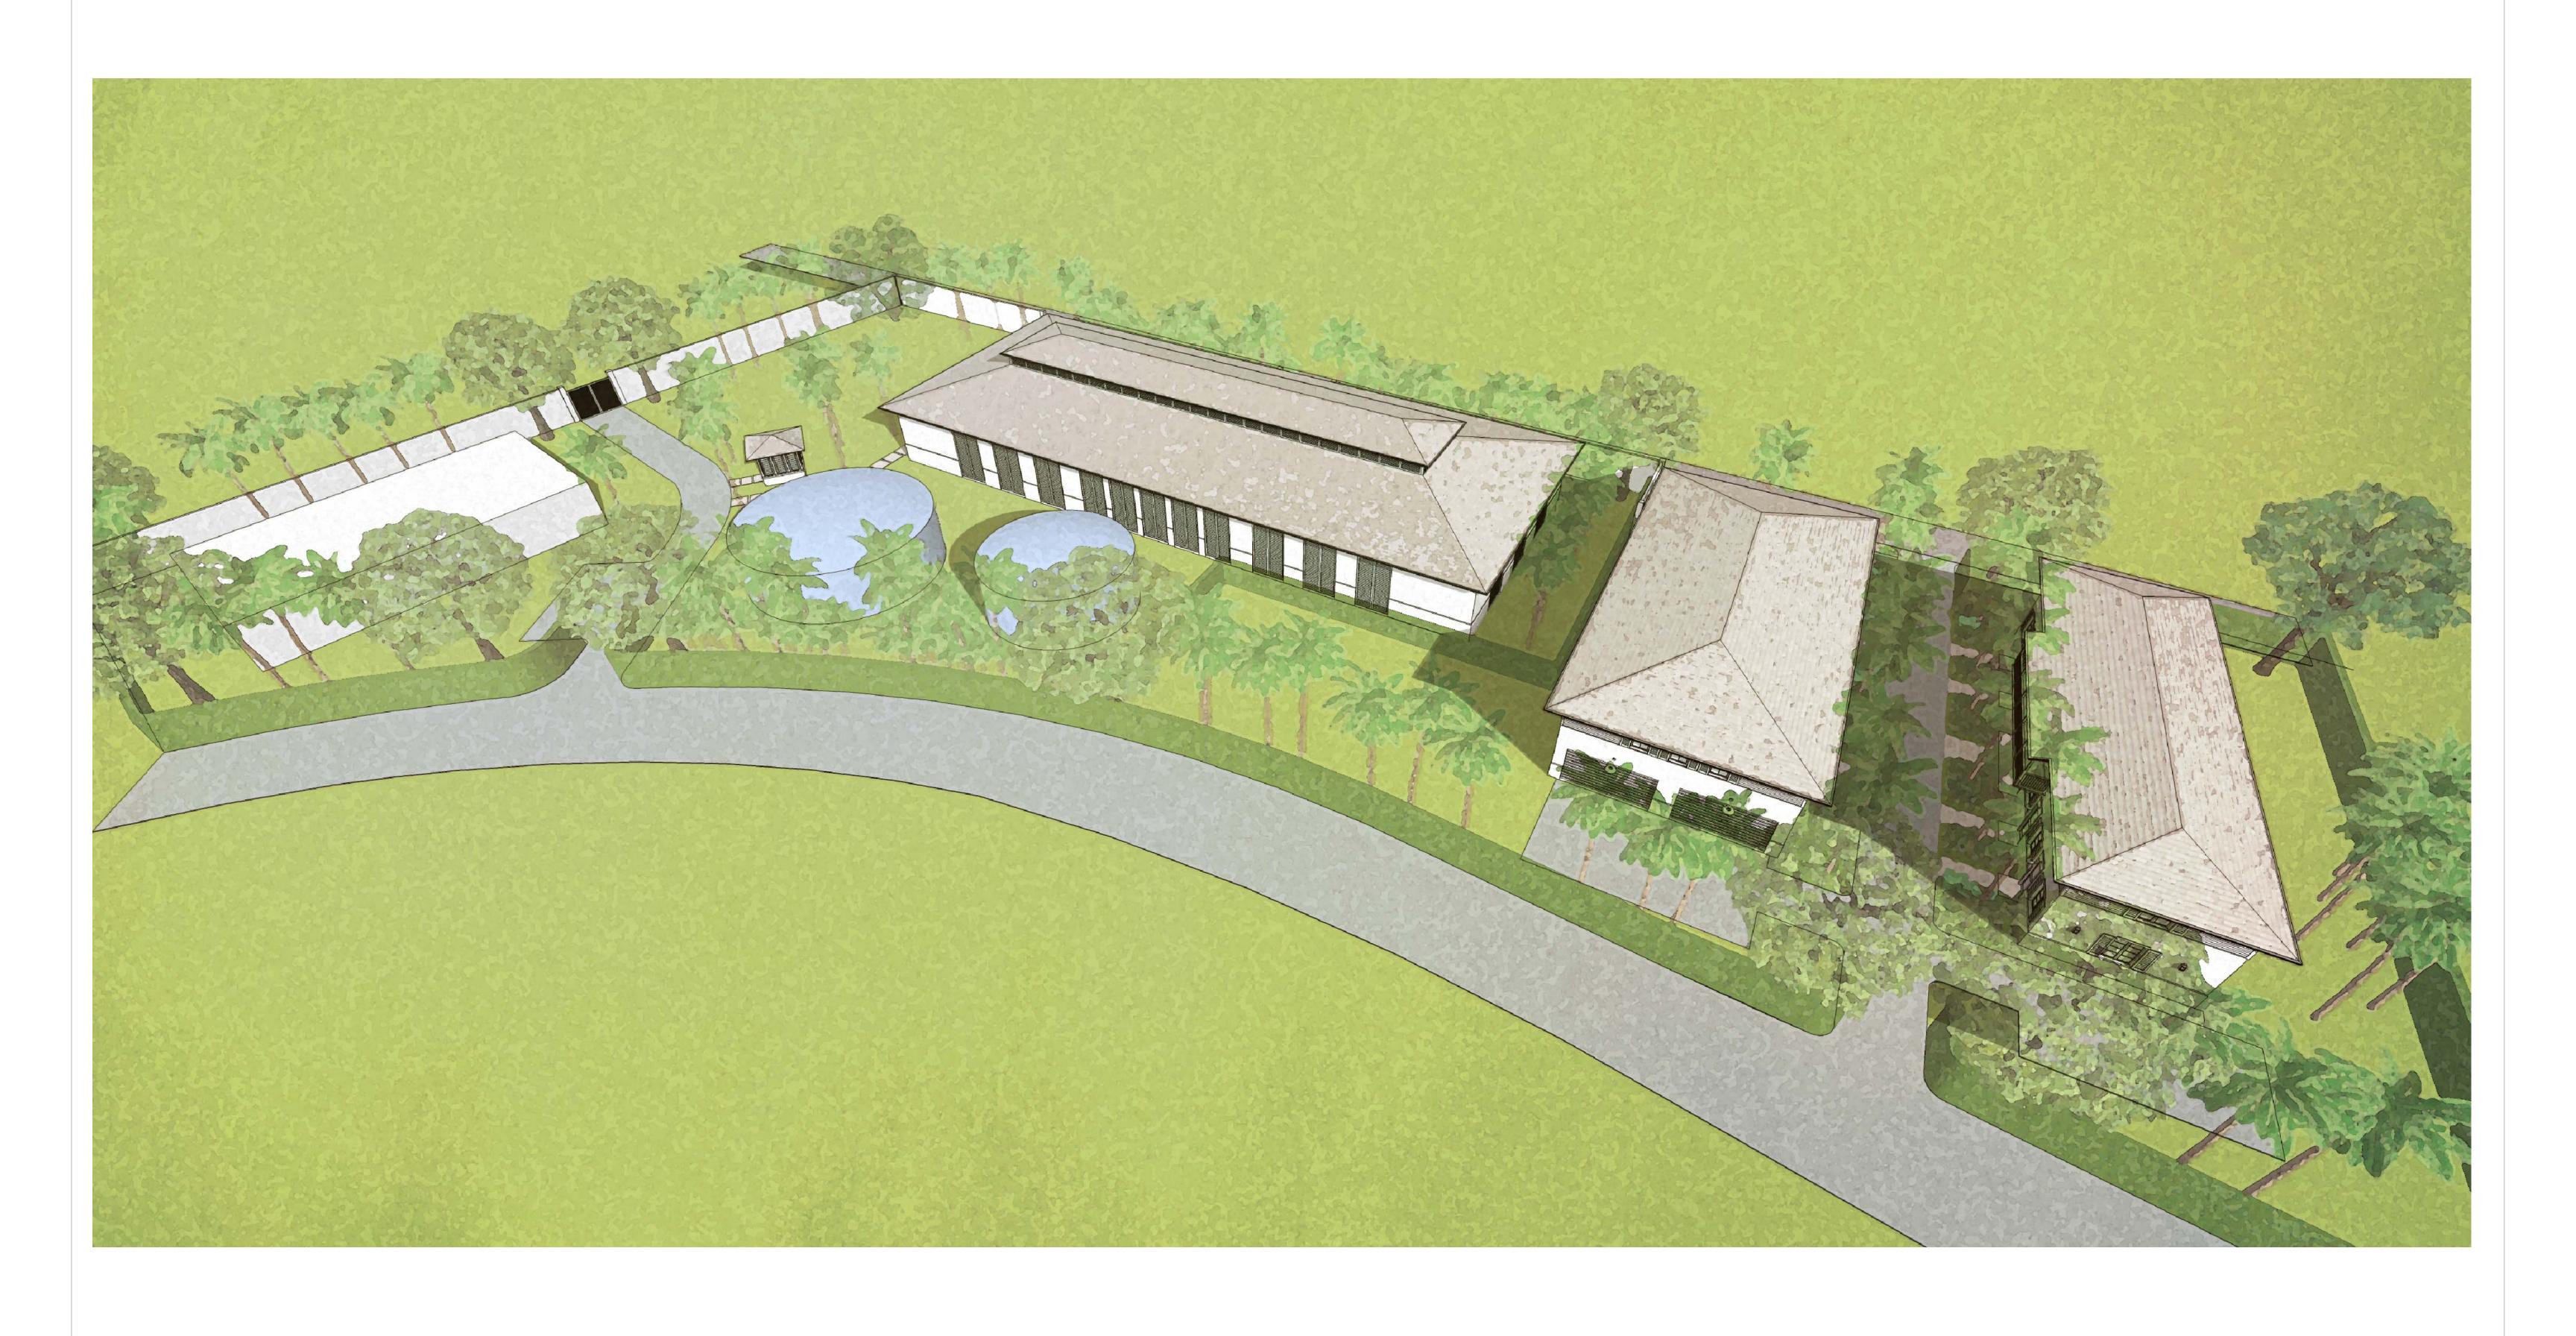
BACK OF HOUSE - AERIAL RENDERING SCALE: N.T.S.

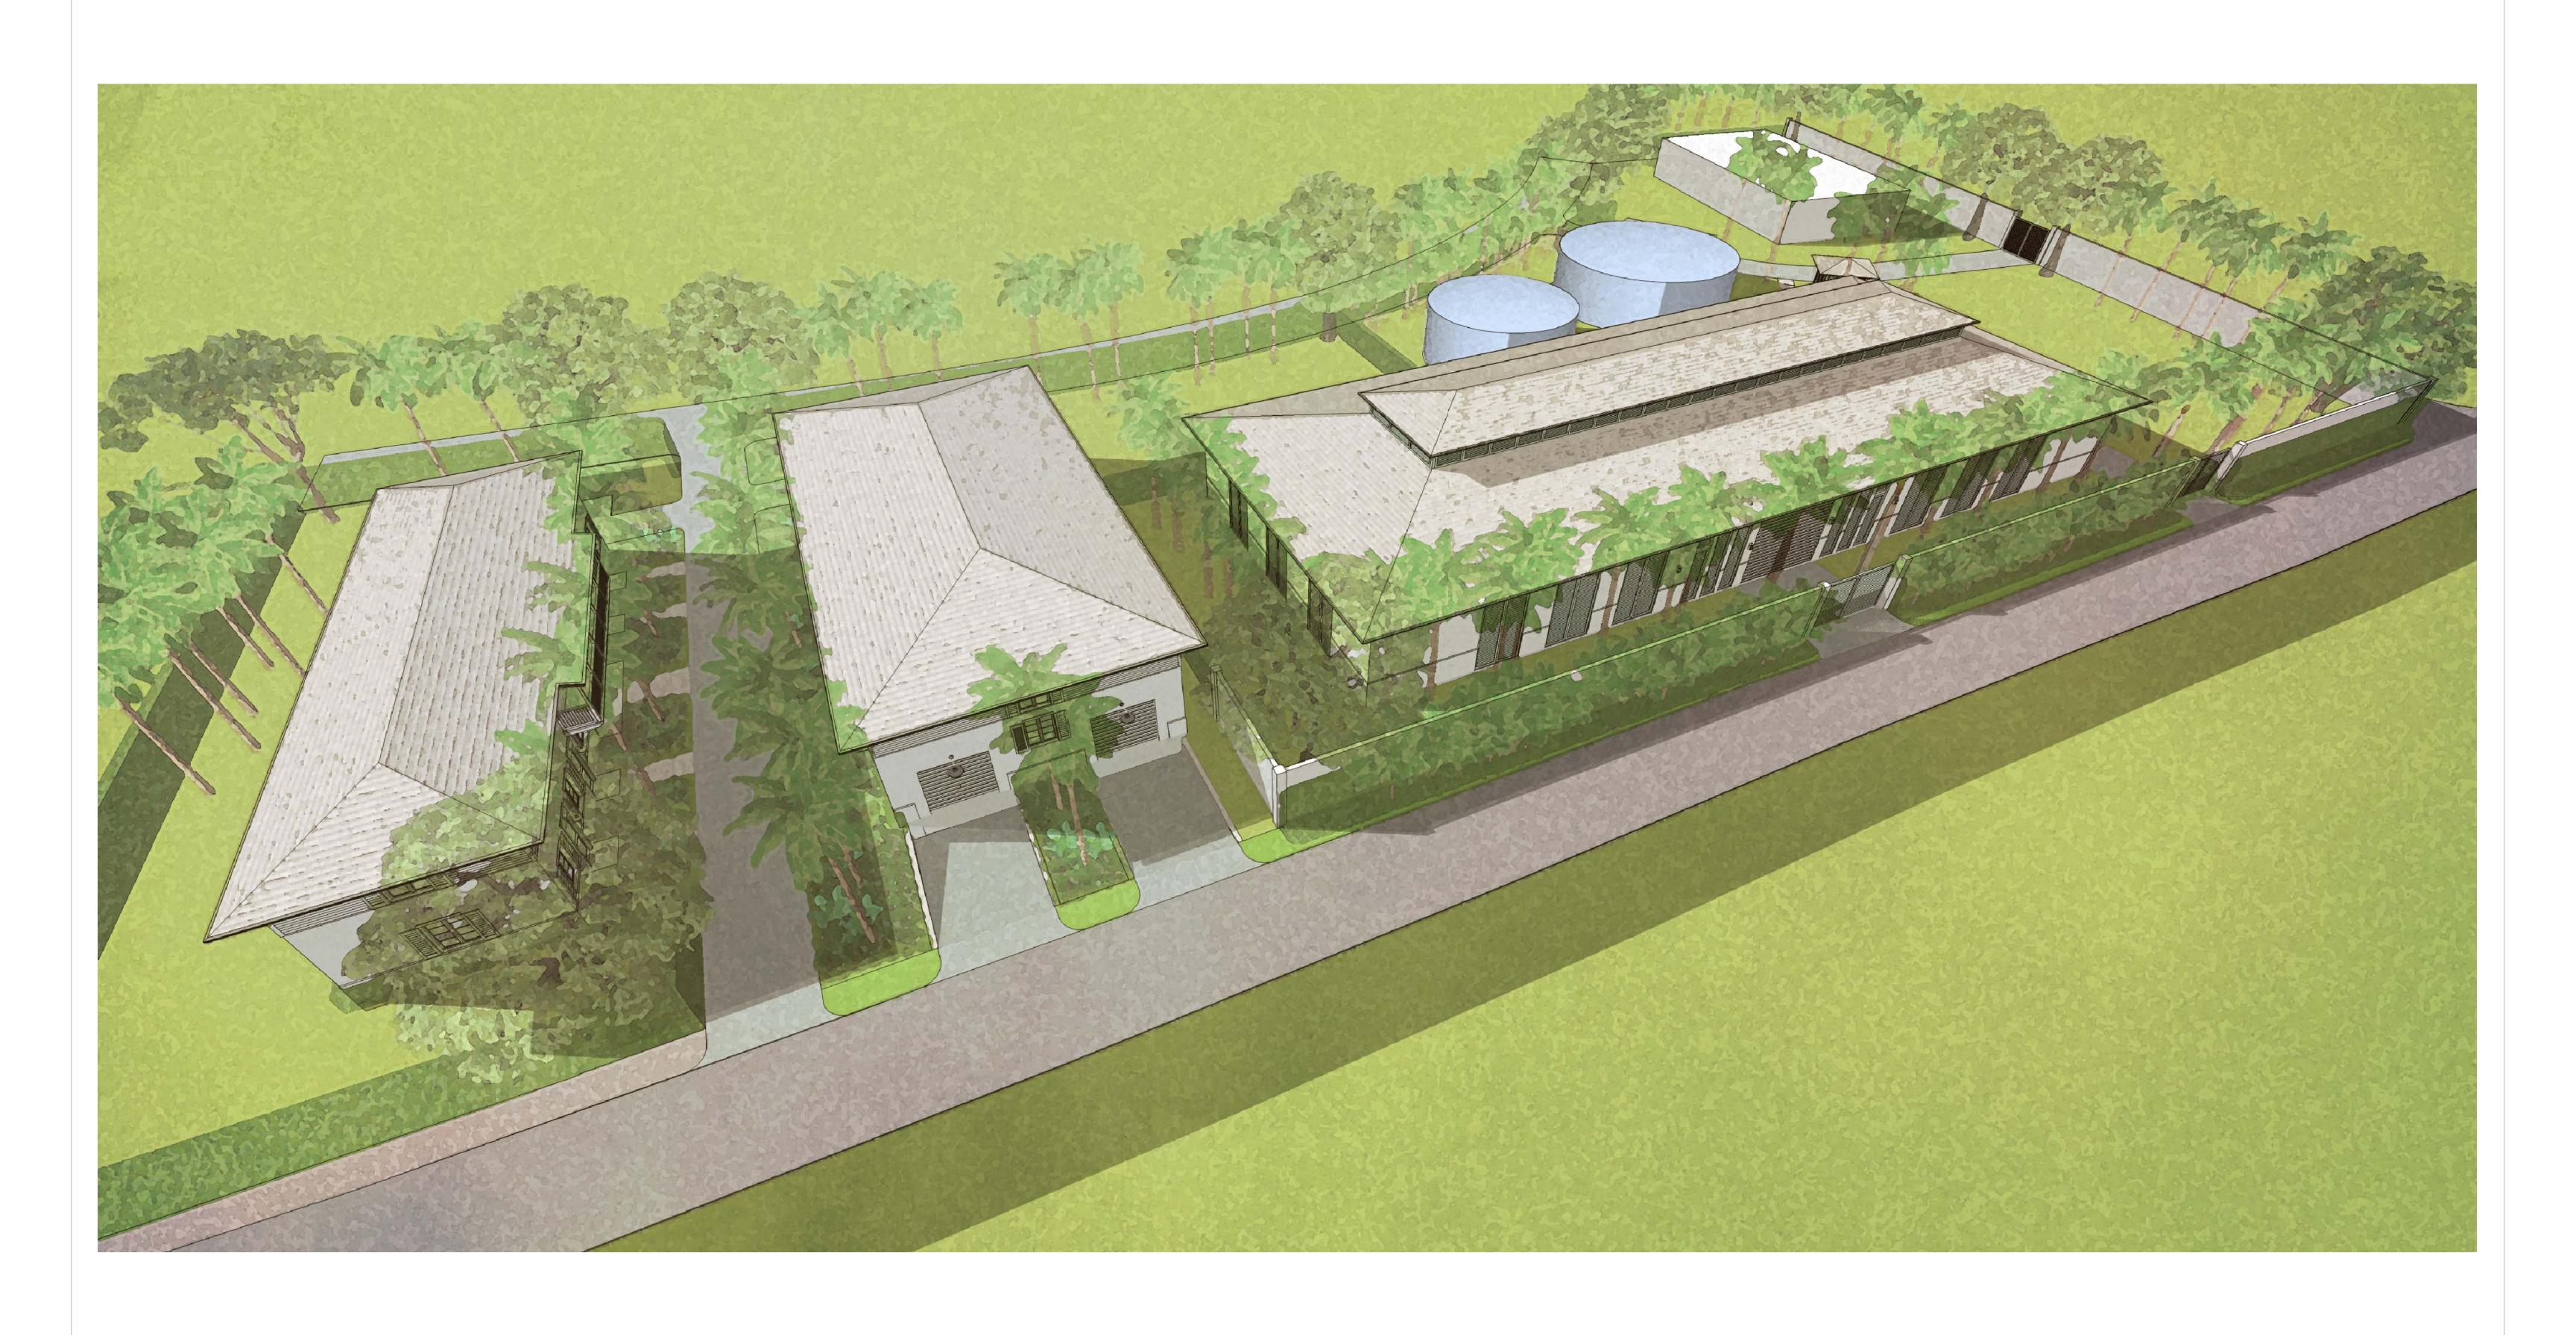
BACK OF HOUSE - AERIAL RENDERING SCALE: N.T.S.

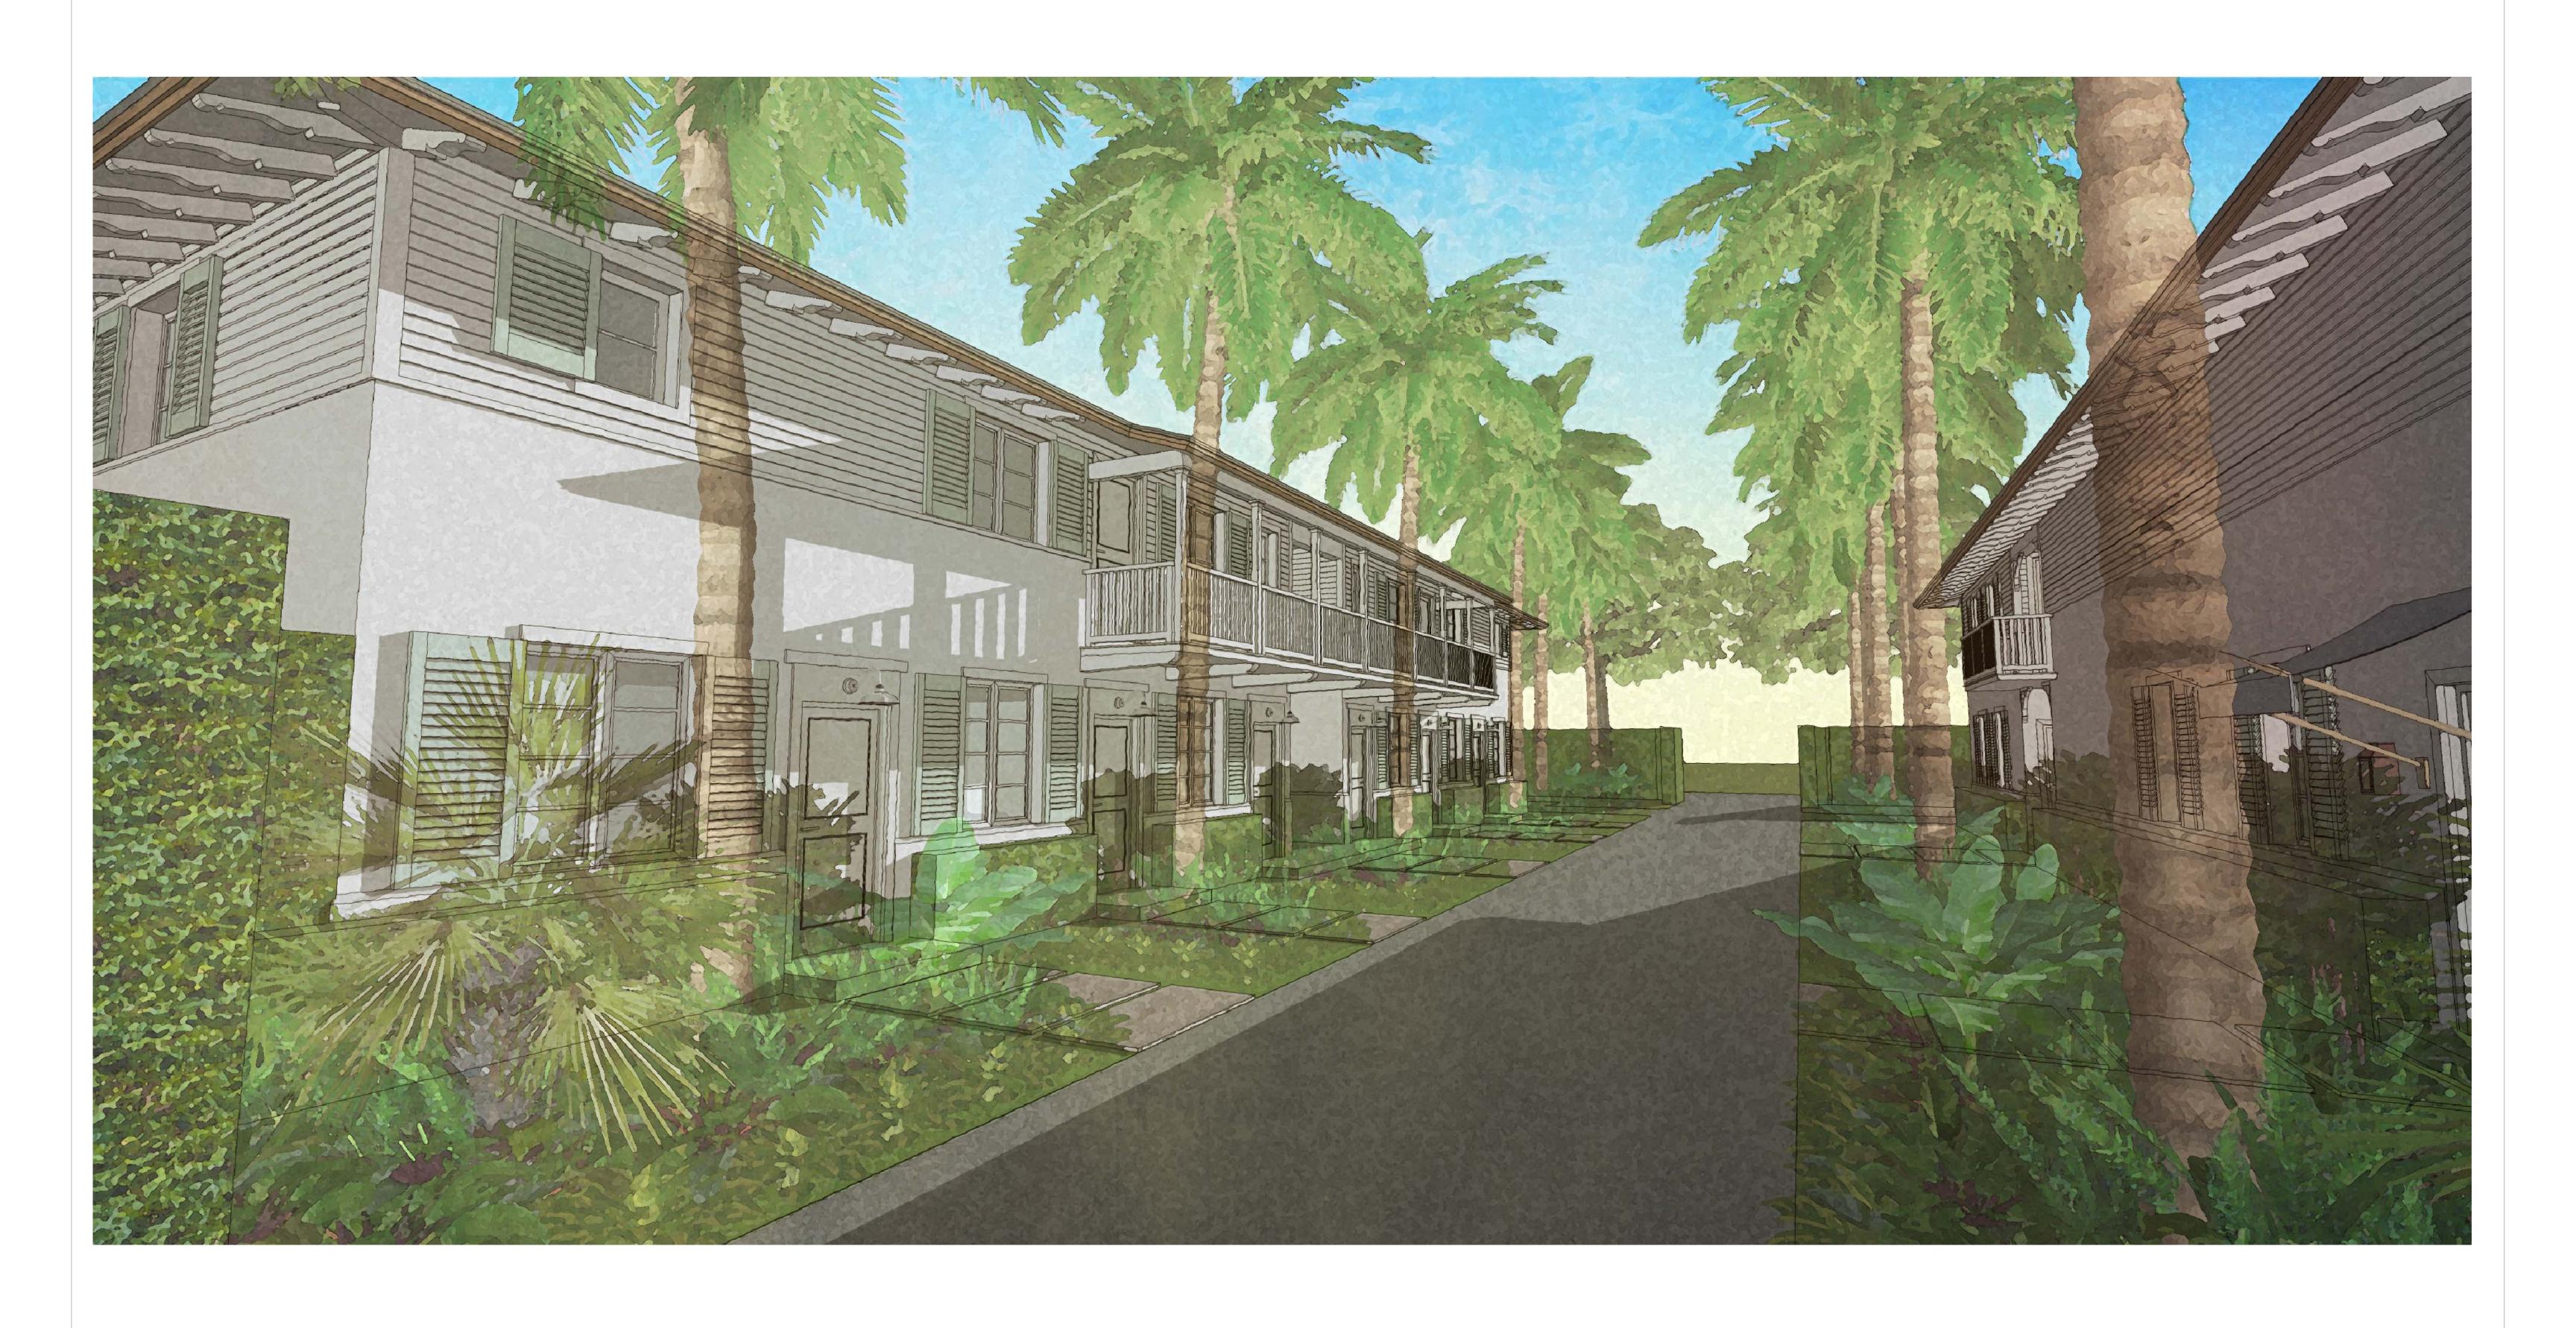
BACK OF HOUSE - RENDERING SCALE: N.T.S.
