# 4M Harbour Island Ltd. Marina Back of House & Utility Corridor Impact Assessment Rev 1

# Utility Corridor & Back of House Description

#### **Utility Corridor**

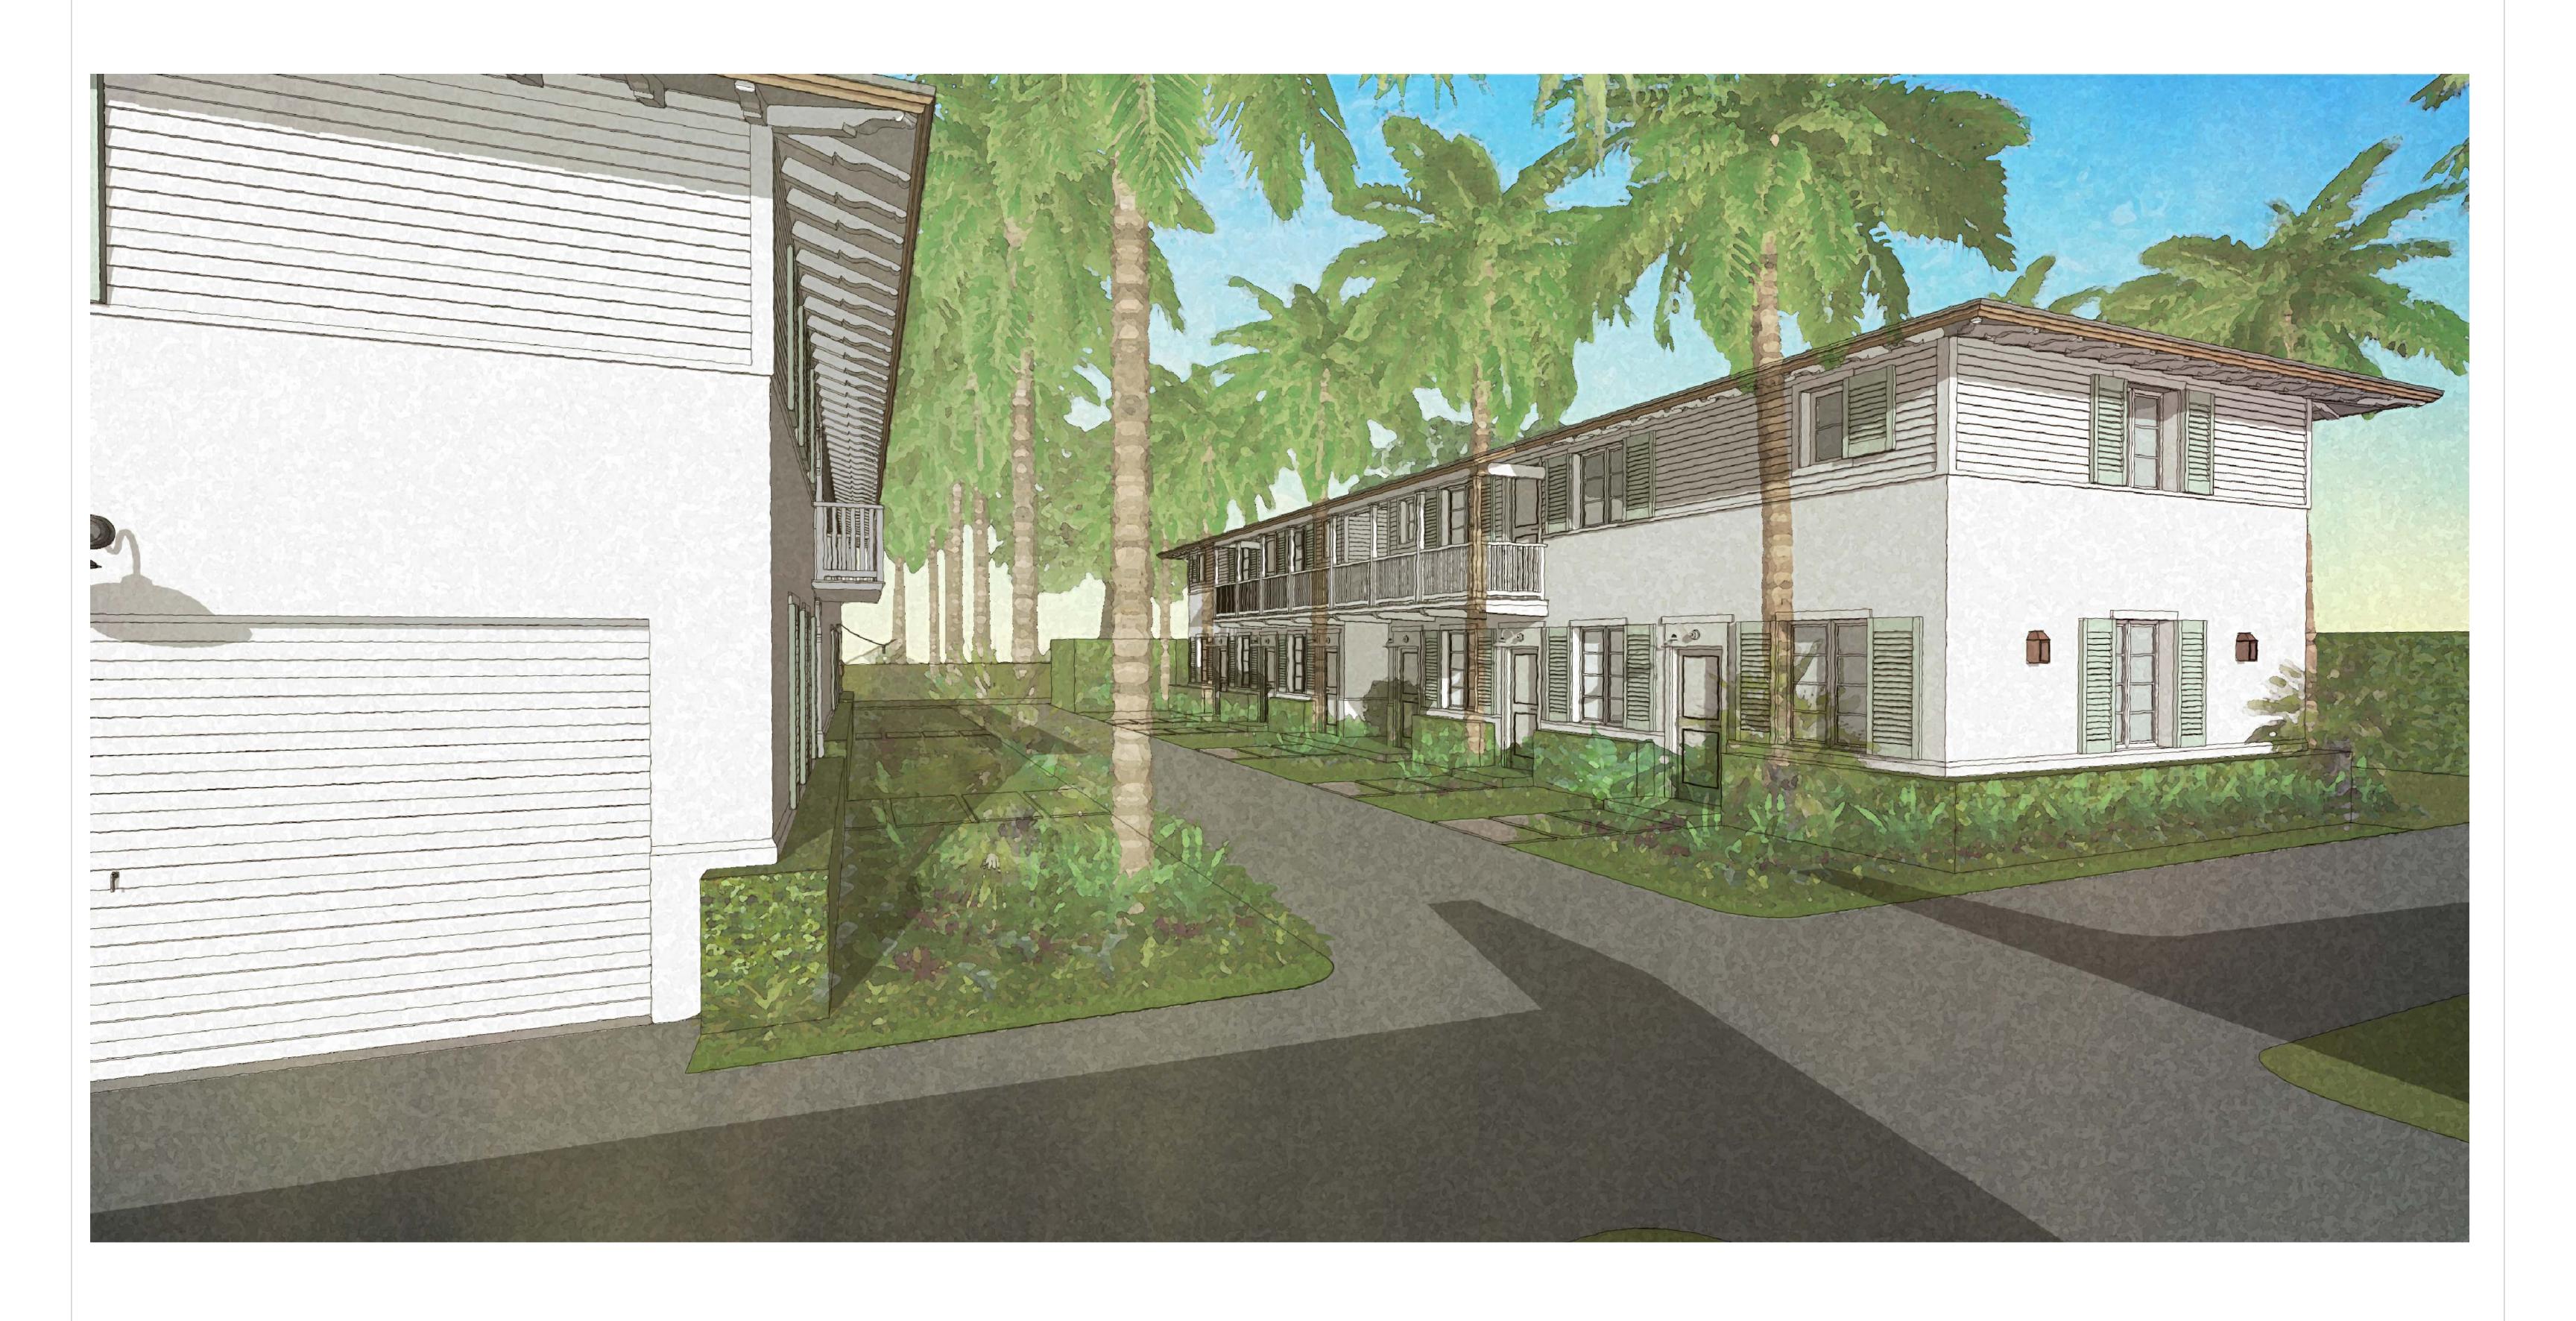
BACK OF HOUSE - RENDERING SCALE: N.T.S.

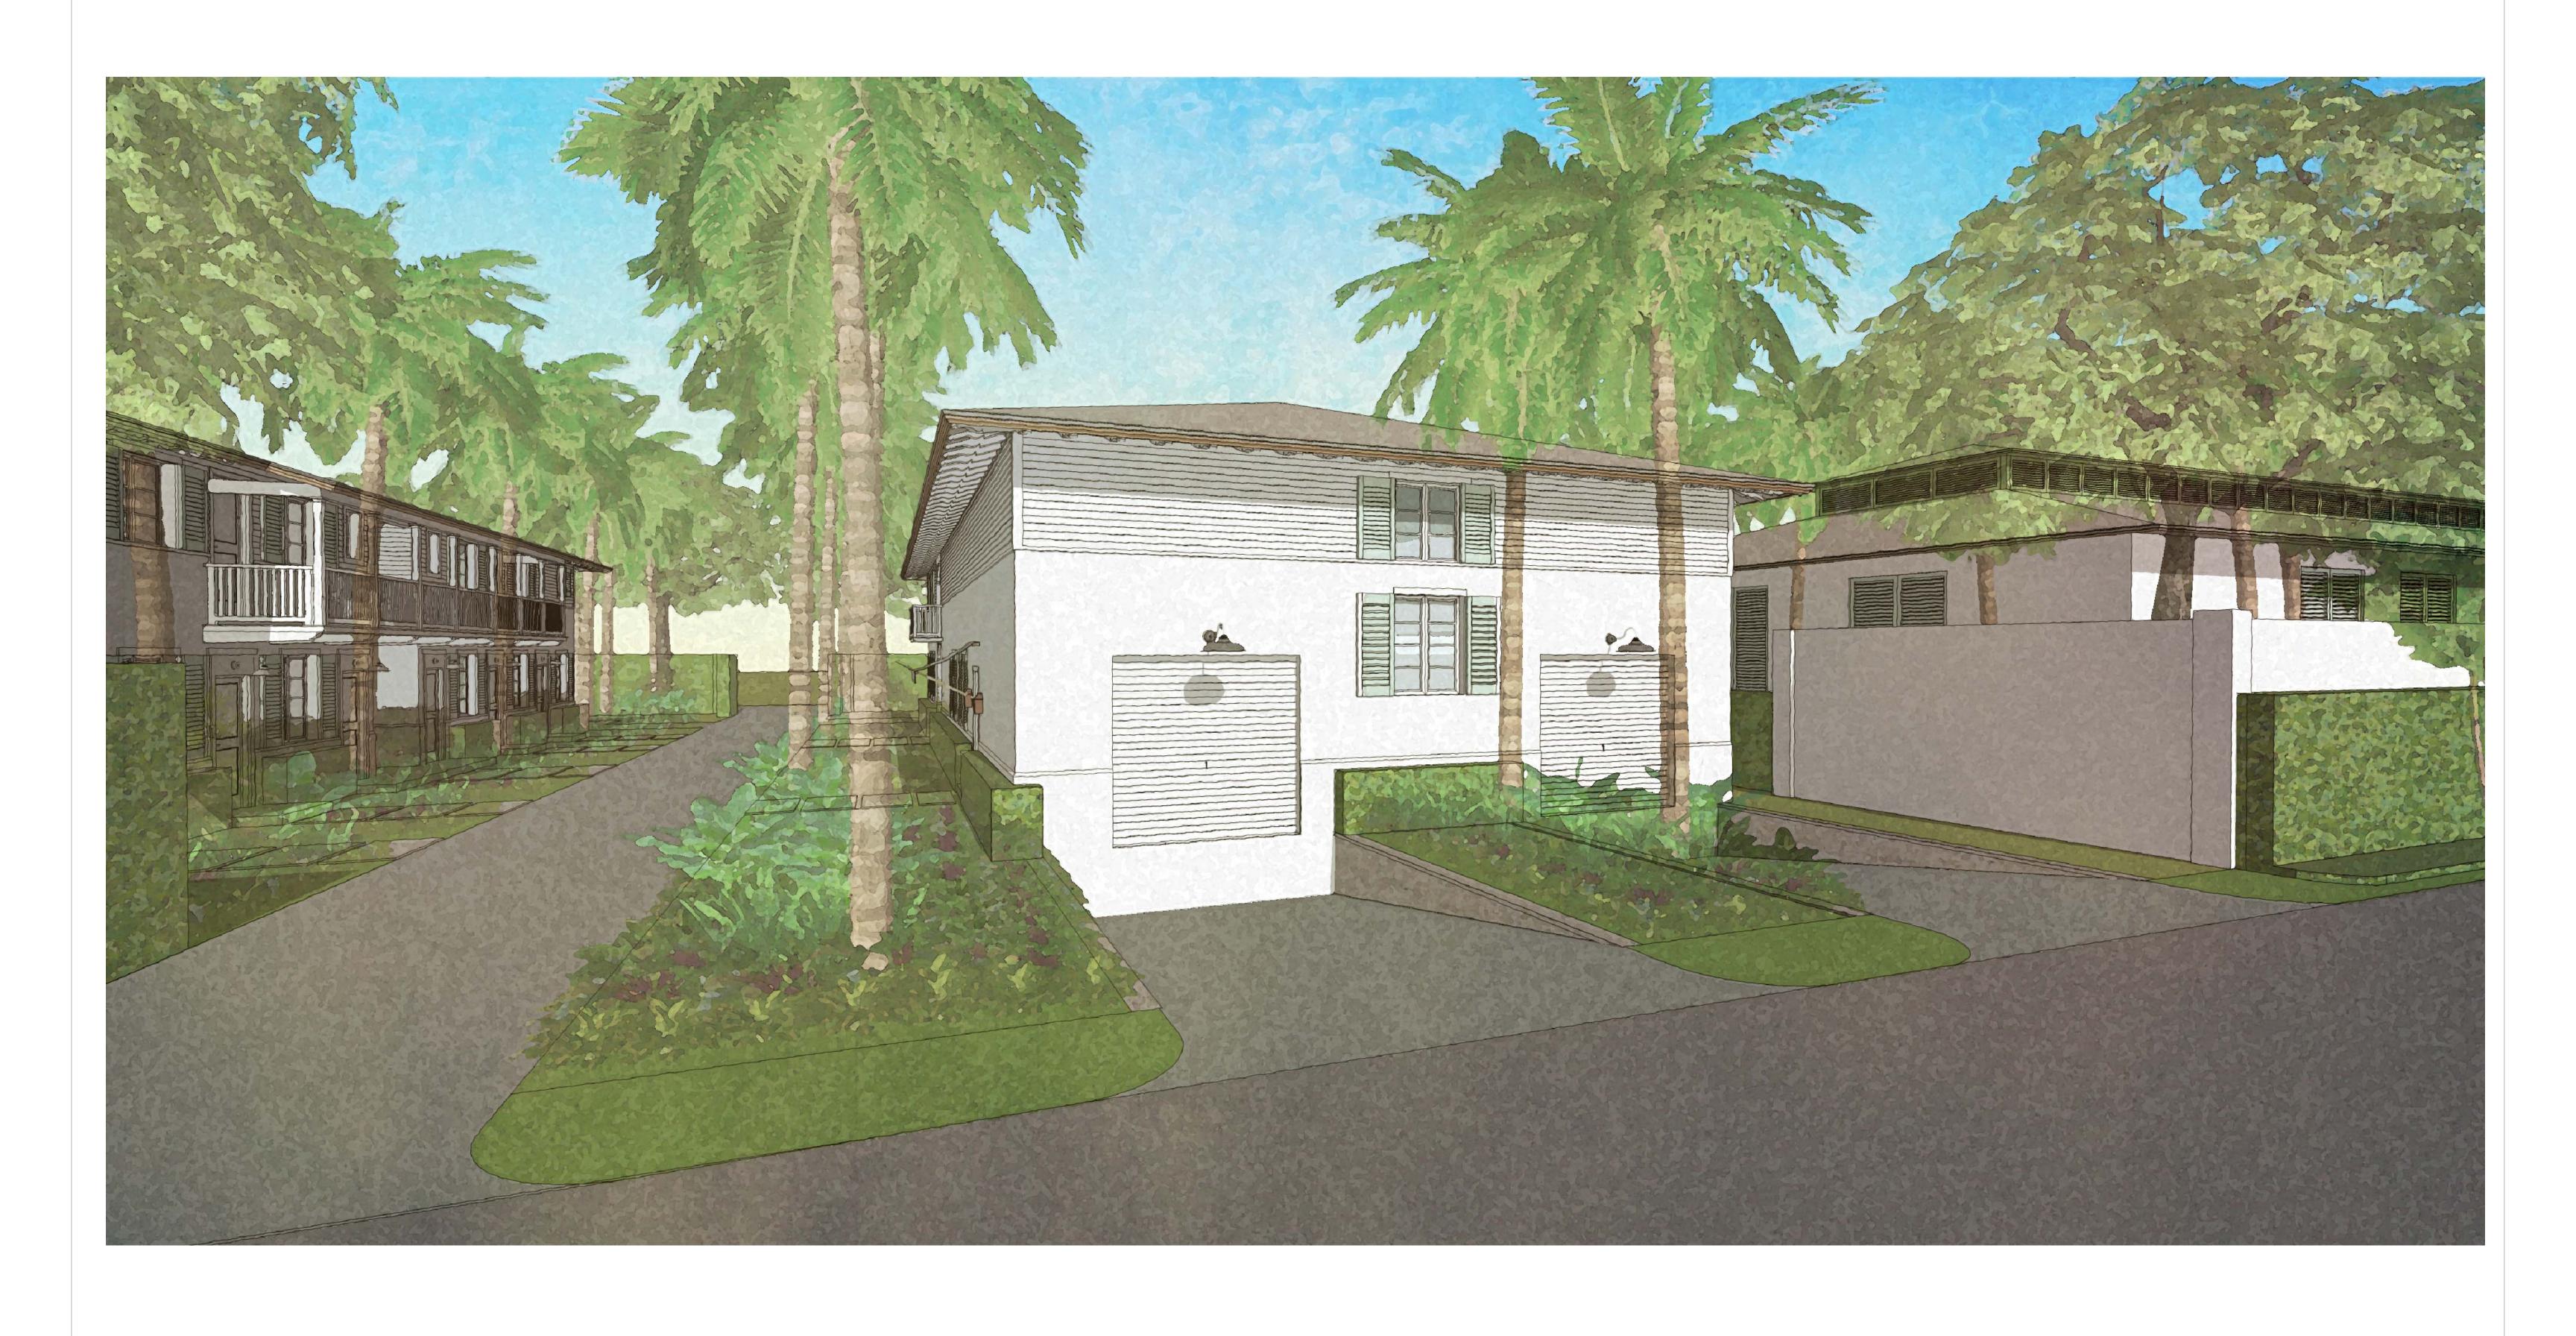
BACK OF HOUSE - RENDERING SCALE: N.T.S.
