Environmental Impact Assessment Addendum 4M Harbour Island Ltd. Project Revision 1

3 December 2020

EIA Addendum · 4M Harbour Island Ltd. Project · 3 December 2020

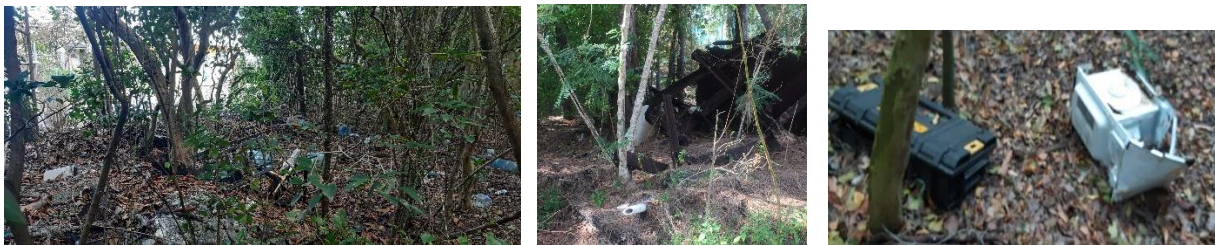
Figure 8. Indiscriminate dumping on portions of the property continued

Indiscriminate dumping was also observed on portions of the property on the west of Queen’s Highway. Vehicles, tires, car batteries, plastic and glass bottles, clothing and appliances were observed throughout the property. See Figures 7, 8, 9, and 10.

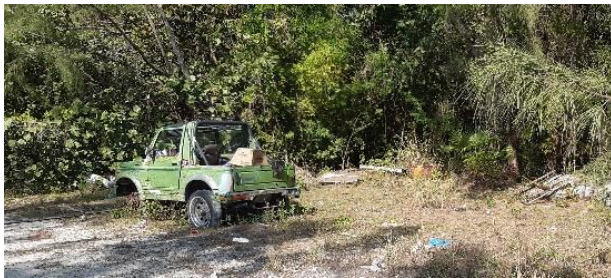
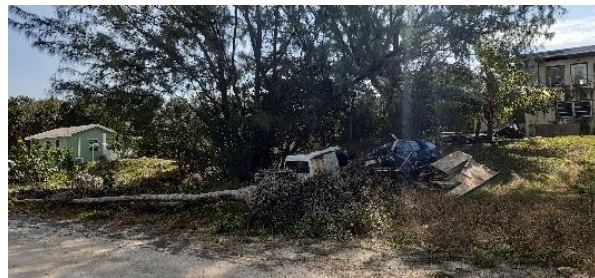
Figure 15. Abandoned vehicles within southern boundary of the property

There is evidence of fishing in the area as a small conch midden and fish skeletons were observed in the former landing strip area. Figure 11 show the conch midden and fish skeletons. Residents adjacent to the northern and southern boundary of the property on the west of Queen’s Highway appear to be using the area near the landing strip property to park vehicles, boats, store equipment, and to access their properties. Figures 12 and 13 show vehicles parked within the northern boundary of the property. Figure 14 shows vehicles, boats and trailers stored within the southern boundary of the property. Figure 15 shows abandoned vehicles located along the southern boundary of the property.

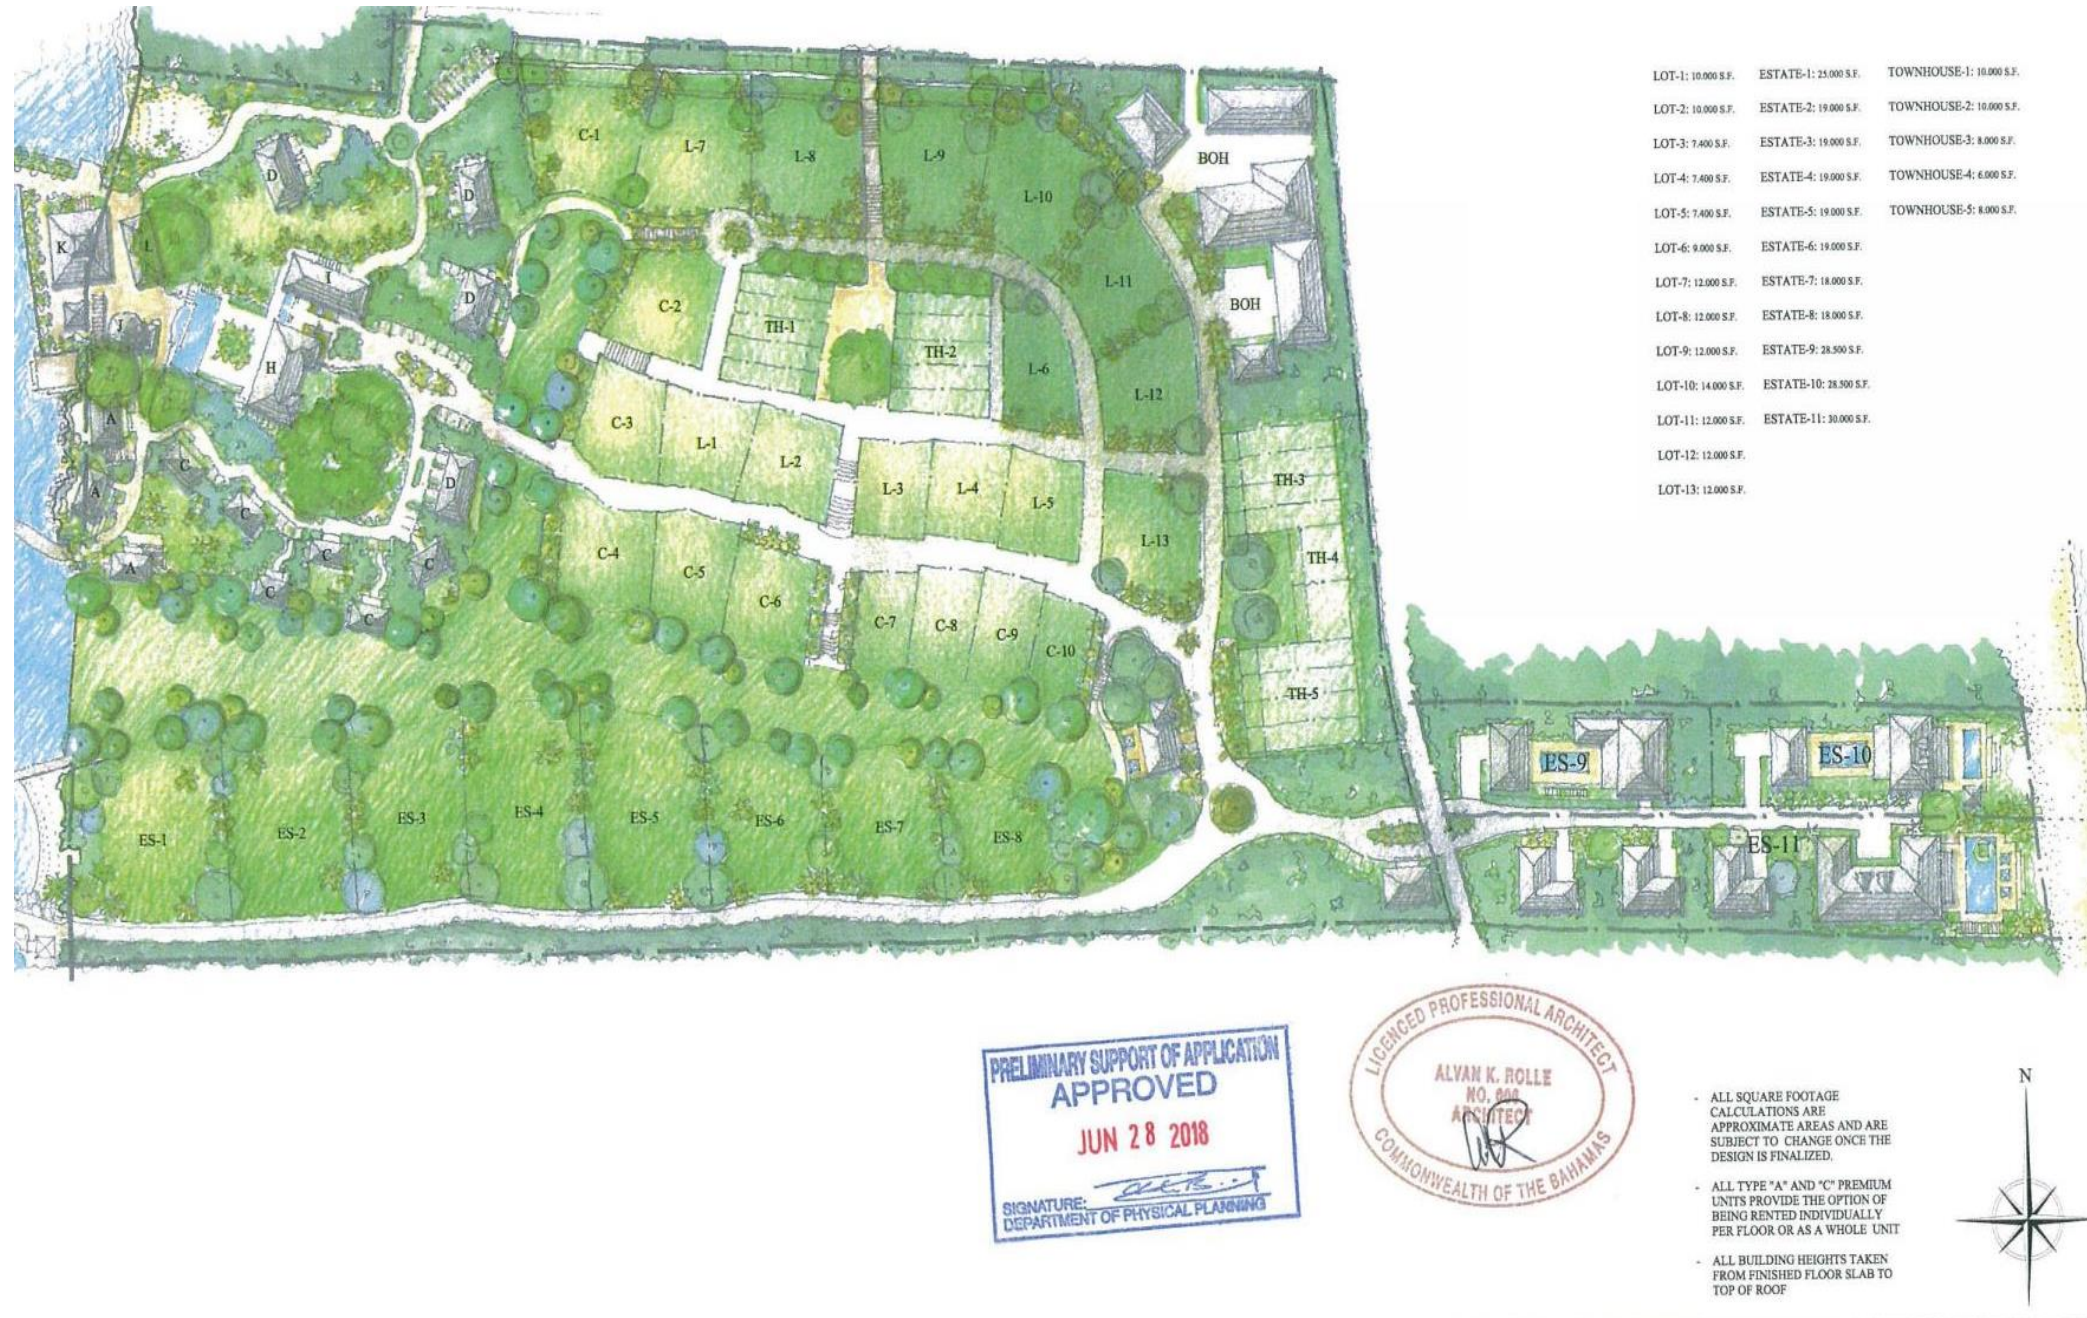
Figure 16. Site Plan for the 27 acre property, including the 5.61 acres and the BOH area.

OVERALL SITE PLAN SCALE: 1/64"=1'-0"
Schematic Design May 2018

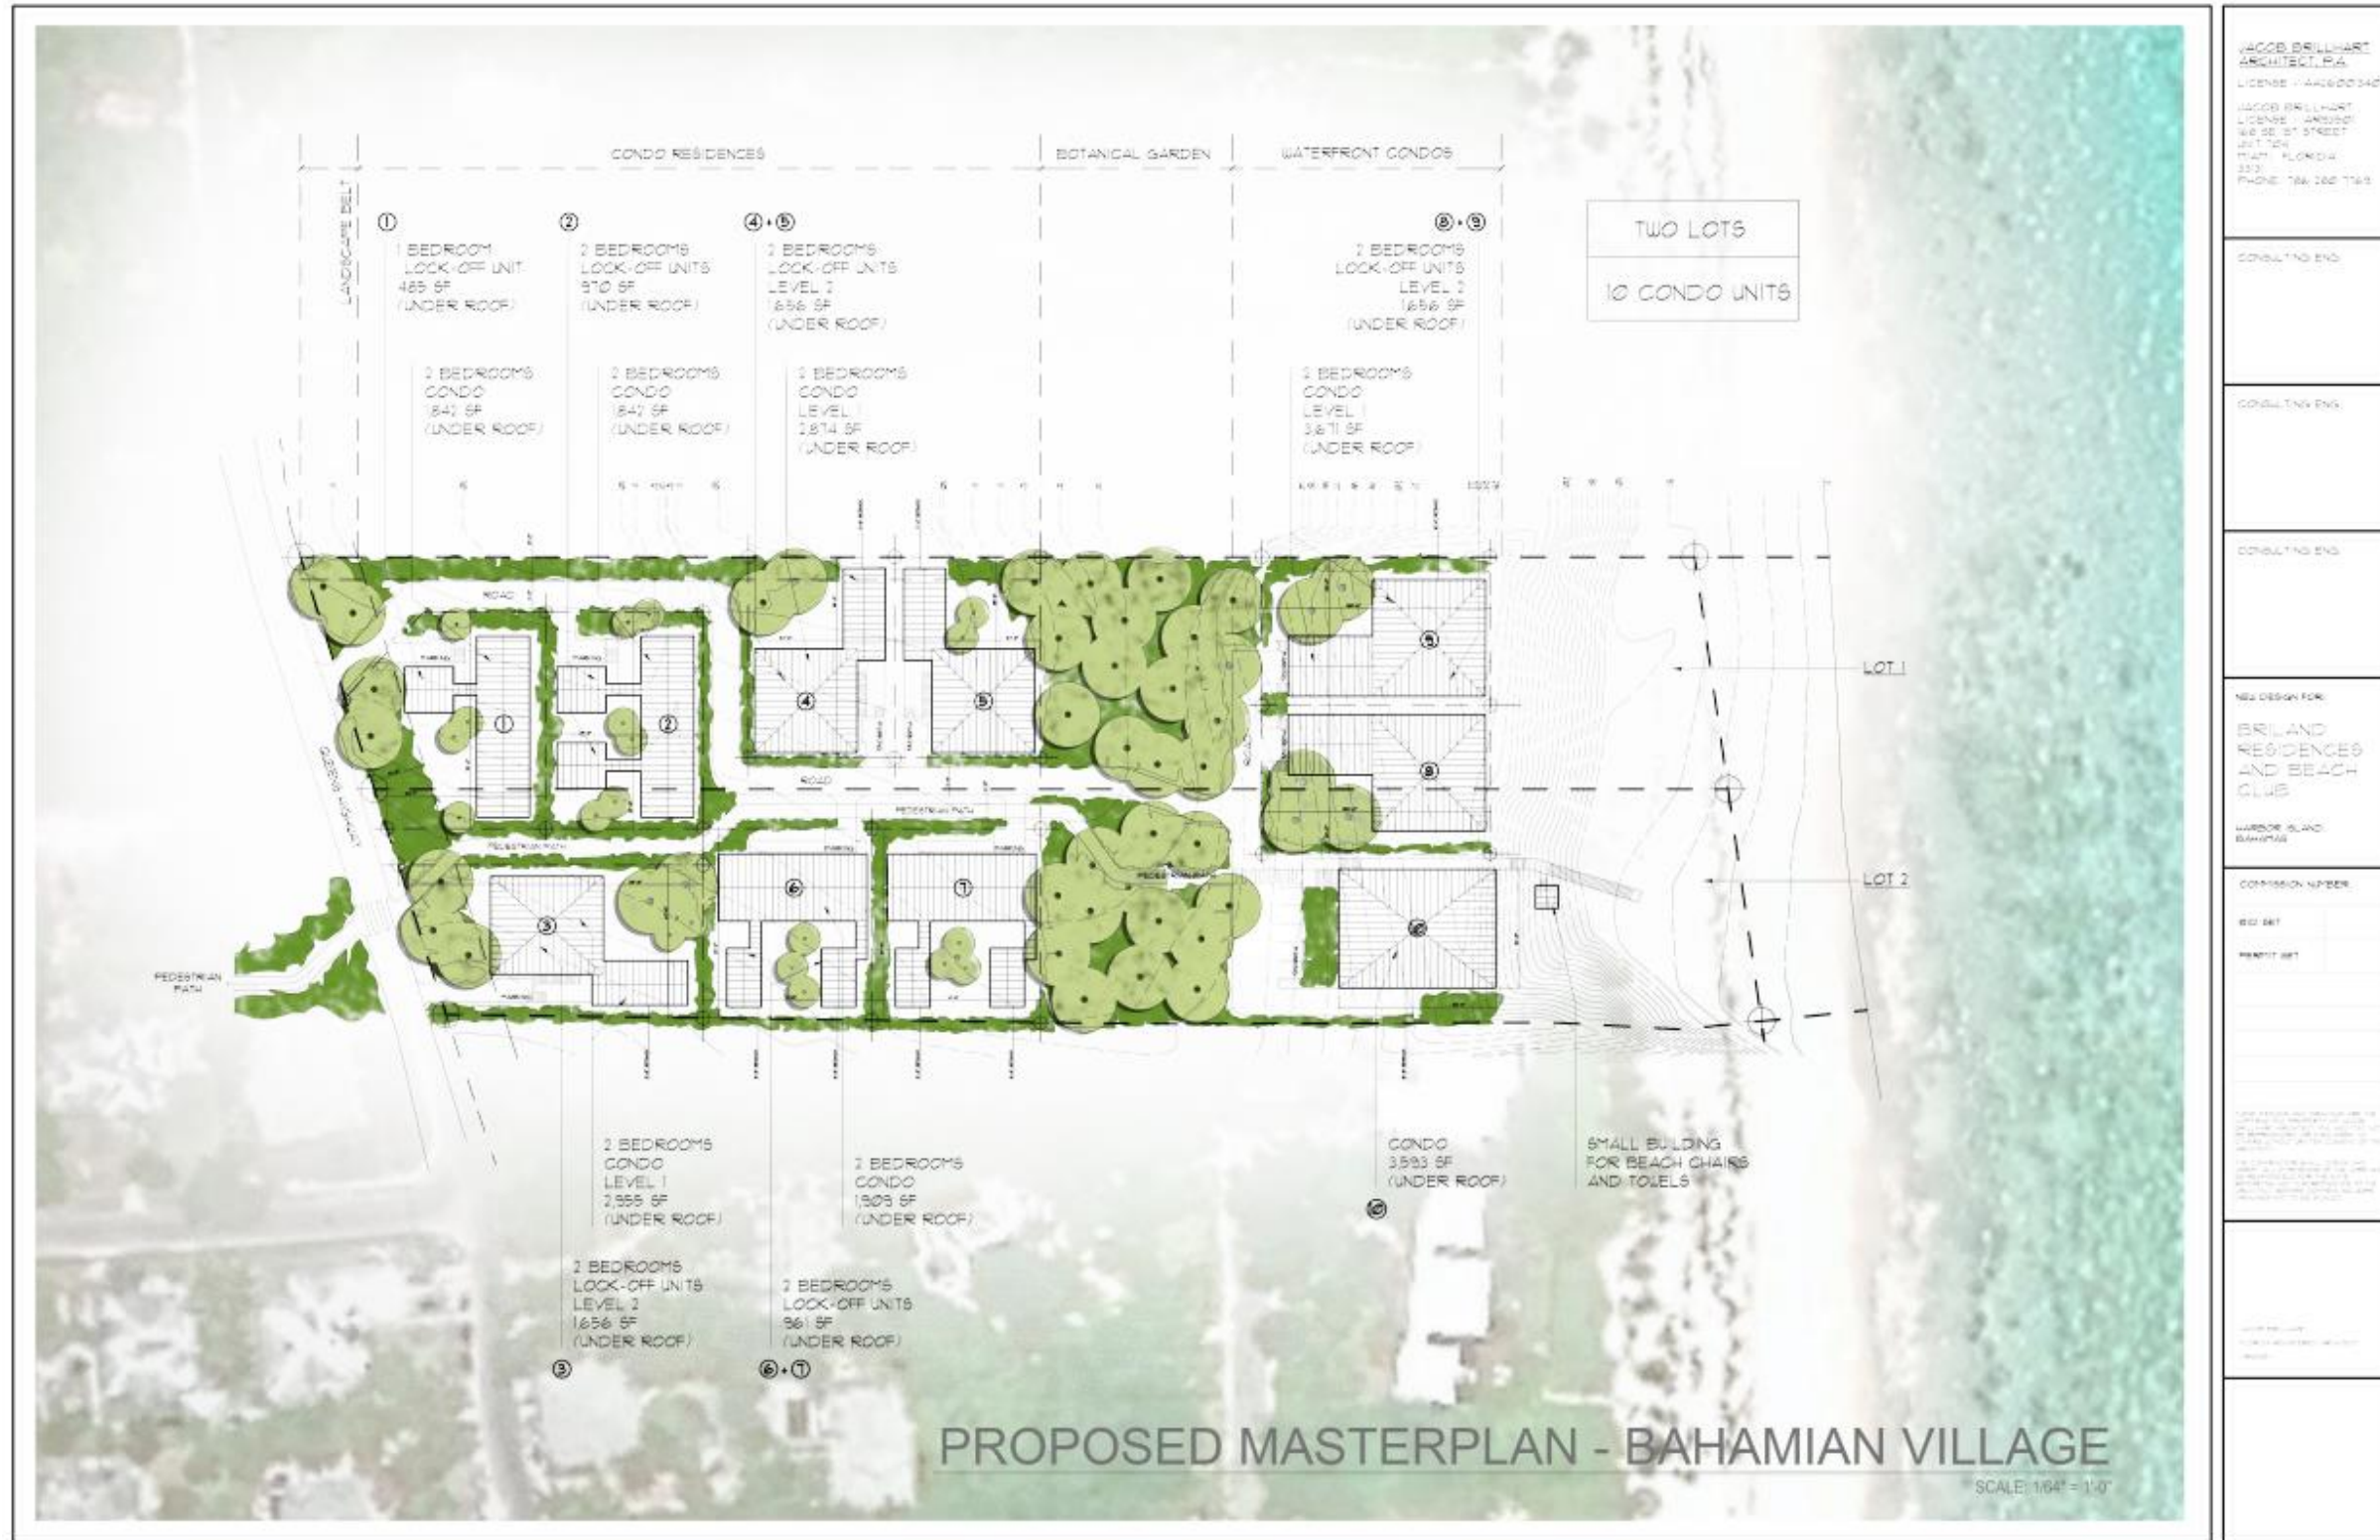
Figure 19. Village Concept for East Lot of the Project site.

Figure 19 on the following page is under consideration for the design of the east lot portion of the property near the popular Harbour Island Pink Sands Beach. This design increases the use of native vegetation on the site with a coconut grove vegetation screen along with other native species plantings. The final design is subject to review and approval of the various agencies responsible, as well as the final design team product.

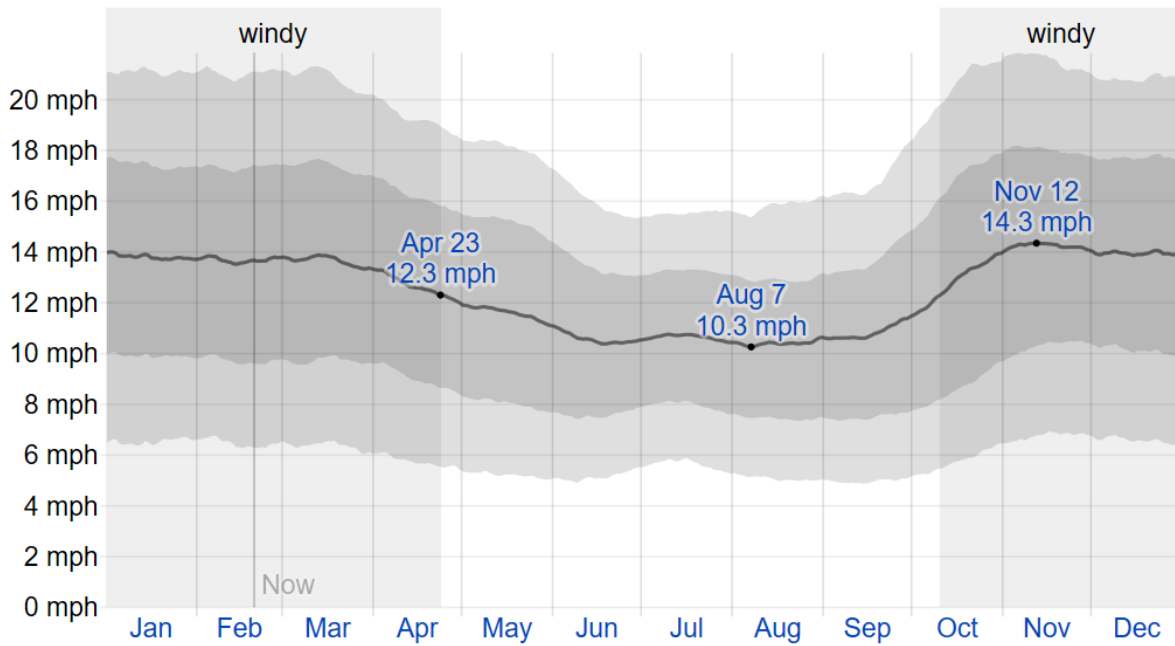
Figure 24. Average Wind Speed in Dunmore Town

The average of mean hourly wind speeds (dark gray line), with 25th to 75th and 10th to 90th percentile bands.

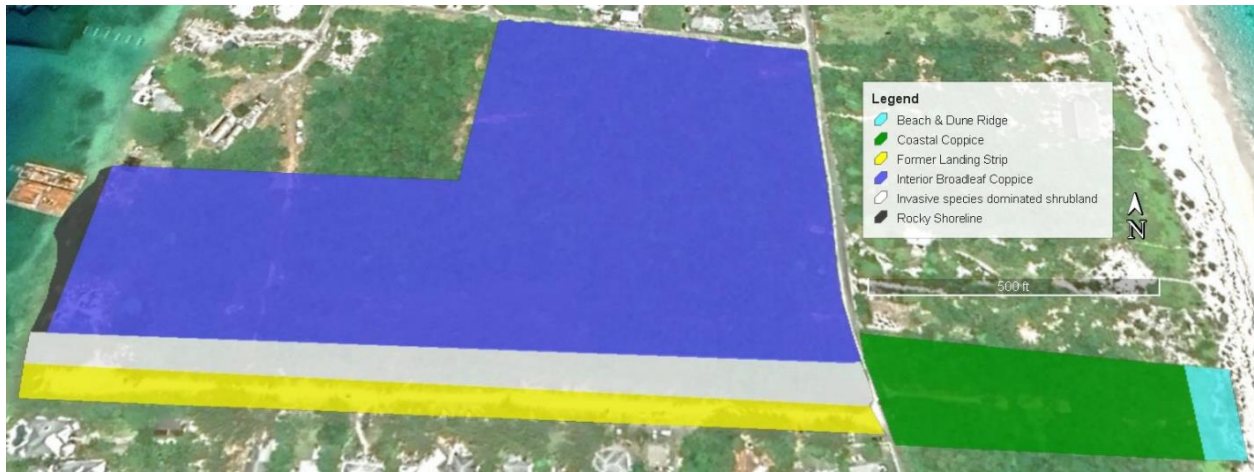
Figure 25. Five (5) different habitats and the Former Landing Strip observed on the 4M2 property

Five (5) habitat types were identified during the site visit in January 2020 by the CCS team. Each habitat is identified by color in the habitat map shown in Figure 23. The five habitat types are Beach and Dune Ridge, Coastal Coppice, Interior Broadleaf Coppice, Rocky Shoreline and Invasive Species Dominated Shrubland. The map also shows the Former Landing Strip. Surveys began in the Beach and Dune Ridge habitat, then progressed in the Coastal Coppice Habitat. The walking relevé surveys continued along the Former Landing Strip and the Invasive Species Dominated Shrubland. The Rocky Shoreline was then surveyed followed by the Interior Broadleaf Coppice. The 4M2 property also includes a 25 feet wide right of way road located along the northern boundary of the property. The right of way road is paved and no species were observed in this area. As a result, it was not included in the habitat map in Figure 25. The 25 feet wide right of way road is included in Figure 3 4M2 Property that lies east and west of Queen’s Highway. Figures 26 through 30 show general habitat photos. Appendix F shows photos of observed species.

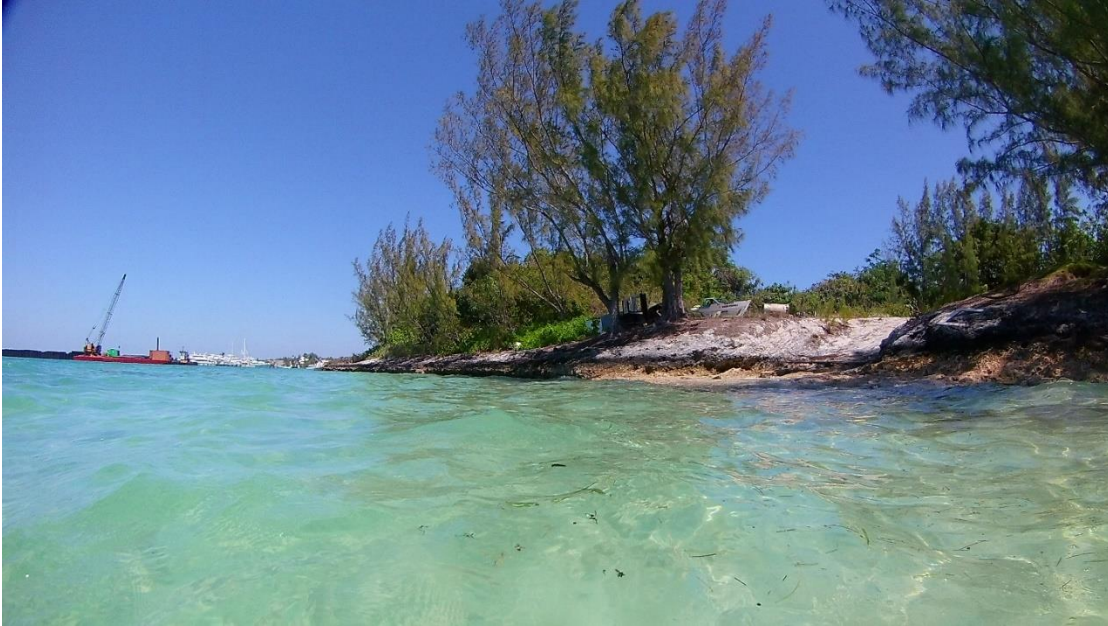
Photo 1: Rocky shoreline of the site with construction activities (view facing north)

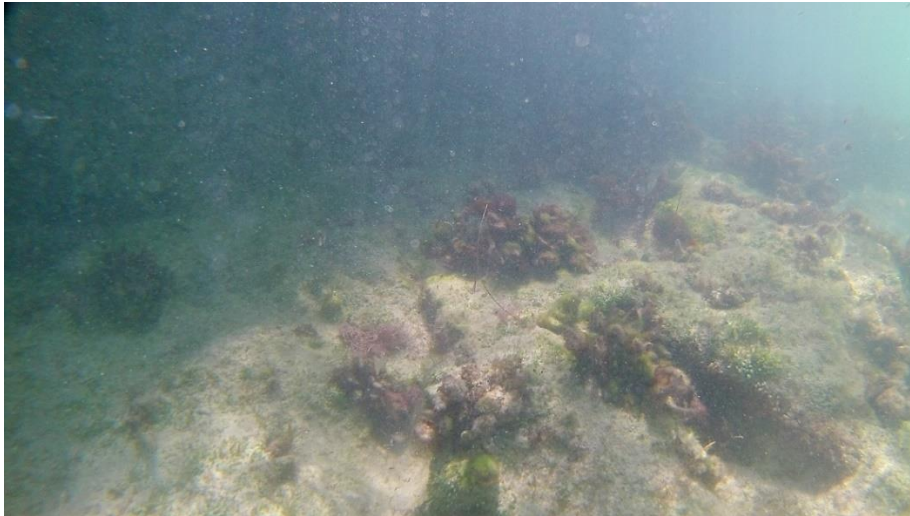
Immediately off from the rocky shore was hardbottom with a thin layer of sand and rubble. The substrate was present along the entire shoreline of the survey area and extended less than five (5) feet seawards. Flora cover included a variety of green and brown algae. Other biota observed in this area was low and included a school of Pilchers (*Ablennes hians*) and a single individual of Cushion Sea Star (*Oreaster reticulatus*).

Photo 3: Hardbottom area with green and brown algae.

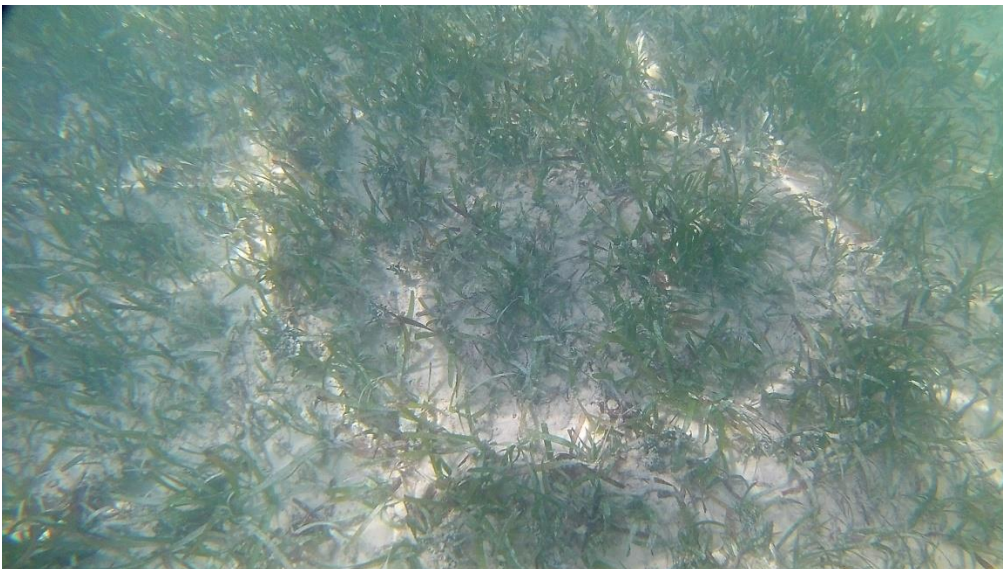
The majority of the substrate in the survey area was sandy bottom. There were large sections with no vegetation and sections dominated by Turtle Grass (*Thalassia testudinum*) and various alga type. The seagrass beds ranged from medium to dense and the grass itself was thick and lush.

Photo 6: Medium density Turtle Grass (*Thalassia testudinum*)

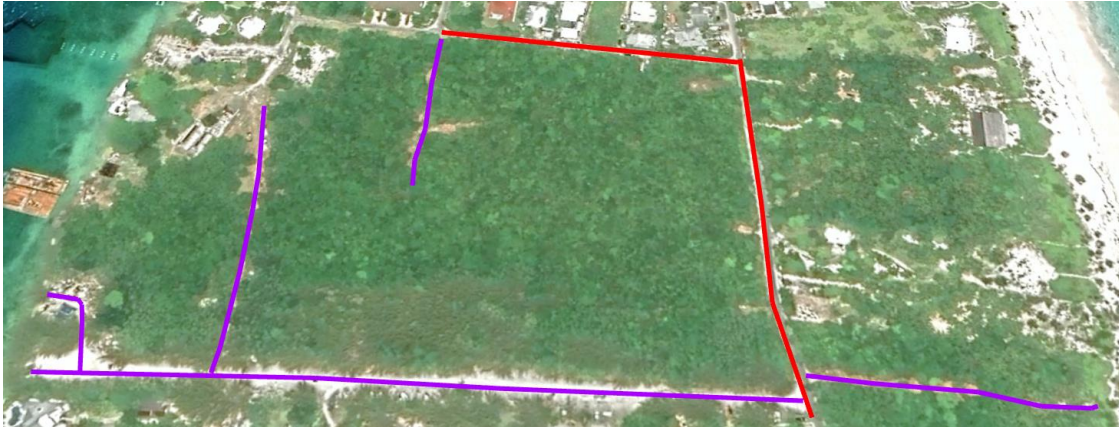
Figure 37. Paved and unpaved roads related to the project site (Google Earth, 2020).

There are two paved roads and five unpaved roads related to the project. Figure 37 shows the paved roads with a red line and the unpaved roads with a purple line. The first paved road is Queen’s Highway, a main road on Harbour Island. It runs north to south on the island and divides the property in two. The second paved road is an access road that runs along the northern boundary of the property as shown in Appendix A. The first unpaved road is the former landing strip that falls within the southern boundary of the property east of Queen’s Highway. The remaining unpaved roads are paths that appear to facilitate access to the property for trash dumping.

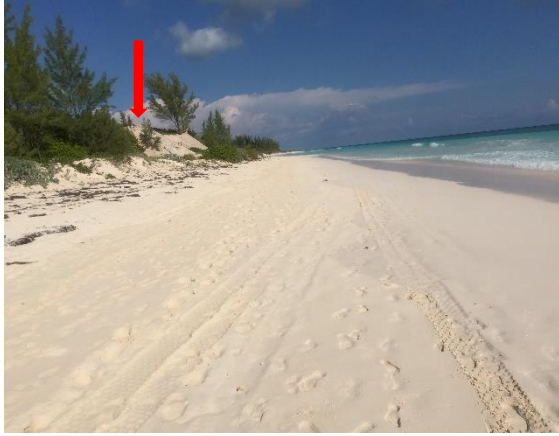
Figure 40. Red arrow shows eroding dune along Pink Sands Beach

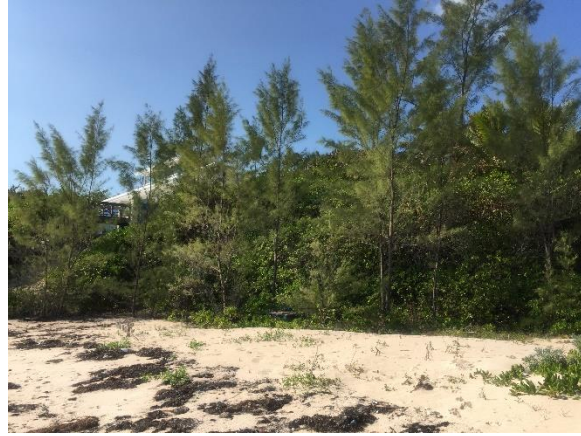
Figure 41. Casuarina within the dune leading to dune erosion
